**TOPOI C-6-8: BATHING CULTURE AND THE DEVELOPMENT OF URBAN  
SPACE: CASE STUDY POMPEII  
REPORT OF THE SEVENTH SEASON, MARCH/APRIL 2019**

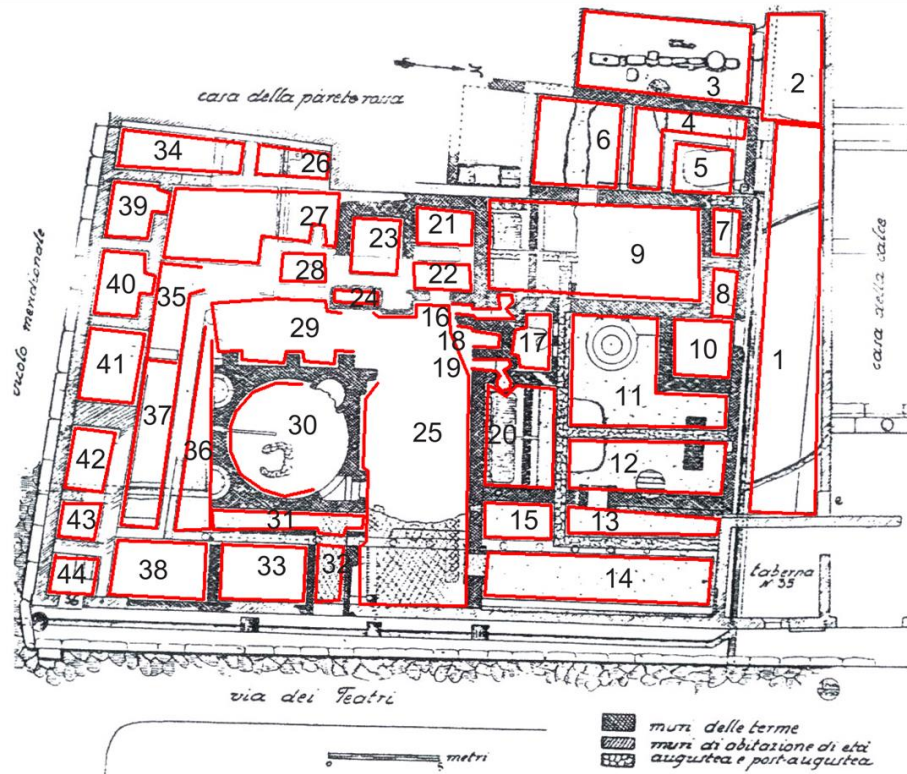
Fig. 2: Republican Baths: plan with room numbering system of the Topoi Project/FU Berlin; (© Topoi Project/FU Berlin)

4. Remodeling of the garden peristyle section, sometime in the early Imperial period; measures included the construction of a series of small rooms in the south (fig. 2: 39-44), and of a large room in the open courtyard (fig. 2: 12/13)

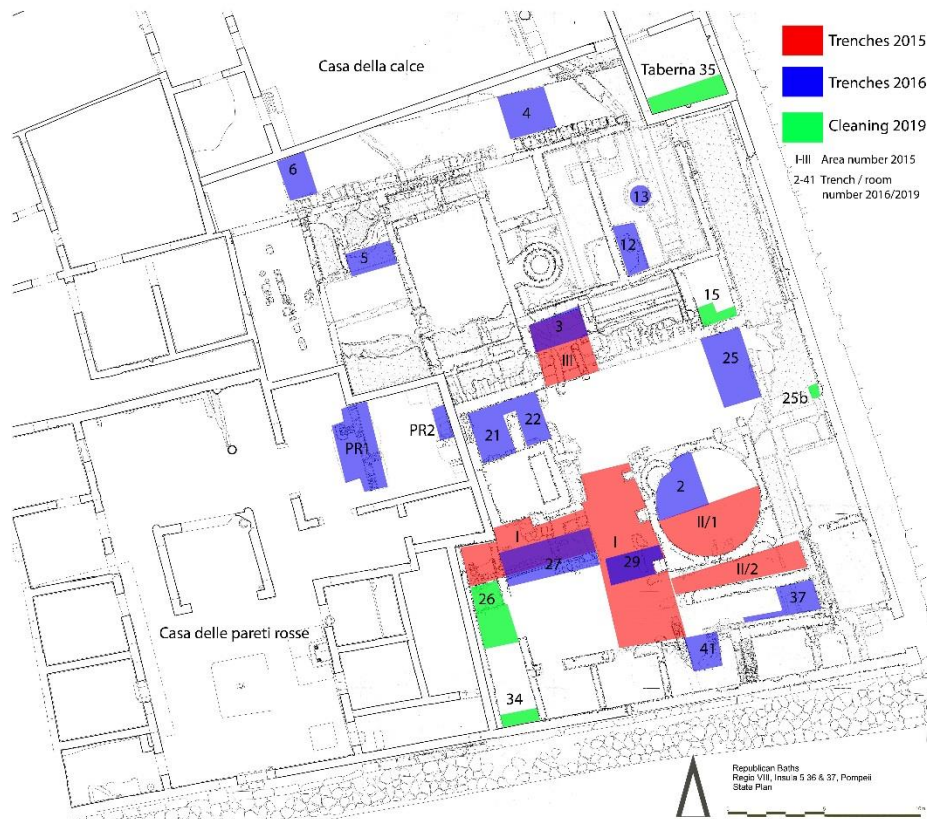
Fig. 3: Republican Baths: plan with trenches and cleaning; (© Topoi Project/FU Berlin)

- The southwest corner of the men's tepidarium (figs. 2-3, room 15) was cleaned in order to study the double outlet close to the southwest corner, which served to drain water from the men's caldarium and tepidarium via the apodyterium into the drainage channel in the via dei Teatri. Thick deposits of calcareous concretions were found along the west wall of the tepidarium and on the floor, confirming observations made in other parts of the baths (esp. men's caldarium and immersion pool). Red stucco was well preserved on the west wall of the room. Full cleaning of this part of the men's tepidarium is hindered by a large tree, the roots of which are visible on the photo (fig. 5). Why there were two drainage holes in the south wall, one on top of the other, must remain open for now; a similar situation was found in the wall between the men's caldarium and tepidarium, to the south of the connecting door (fig. 4: wall between rooms II and III).

- A deep basin in the southeast corner of the men's apodyterium (fig. 2: room 25; fig. 3: 25b) was cleaned and fully documented. This had already been excavated by Maiuri, but not fully documented (D'Avino 1950 173; Maiuri 1950, 126; Trümper 2018, 99 n. 65). It is 40 x 40 cm large and 40 cm deep. The basin received water from a large shallow open drain, which ran through the southern part of the men's apodyterium (but not exactly along the south wall) and drained water from the men's caldarium, tepidarium and apodyterium. A terracotta pipe in the east wall connected the basin with the large drainage channel in the via dei Teatri. The bottom and walls of the basin are covered with thick layers of calcareous concretions. The size and depth of the basin suggest that a significant amount of dirt and objects were swept away when draining and cleaning the bathing rooms; these had to be filtered and removed before the water entered the street channel. Despite this, a hoard including 90 coins was found in the settling basin q4 in the sidewalk just to the east of the men's apodyterium (fig. 4). This hoard contained Ebusan, Pseudo-Ebusan, and Pseudo-Massaliot, Roman Republican, and Greek coins that were circulating in Pompeii in the early 80s BC. Maiuri and later scholars identified the hoard as a purse that a customer of the baths accidentally dropped when changing in the apodyterium. This scenario is somewhat strange, given the number of coins and particularly when taking the currently accessible features of the drainage system into account. It needs further clarification and assessment. Today, however, the sidewalk outside the baths is covered with modern cement so that the drain and settling basin q4 can no longer be studied (Trümper 2018, 97 n. 57; 101 n. 67).

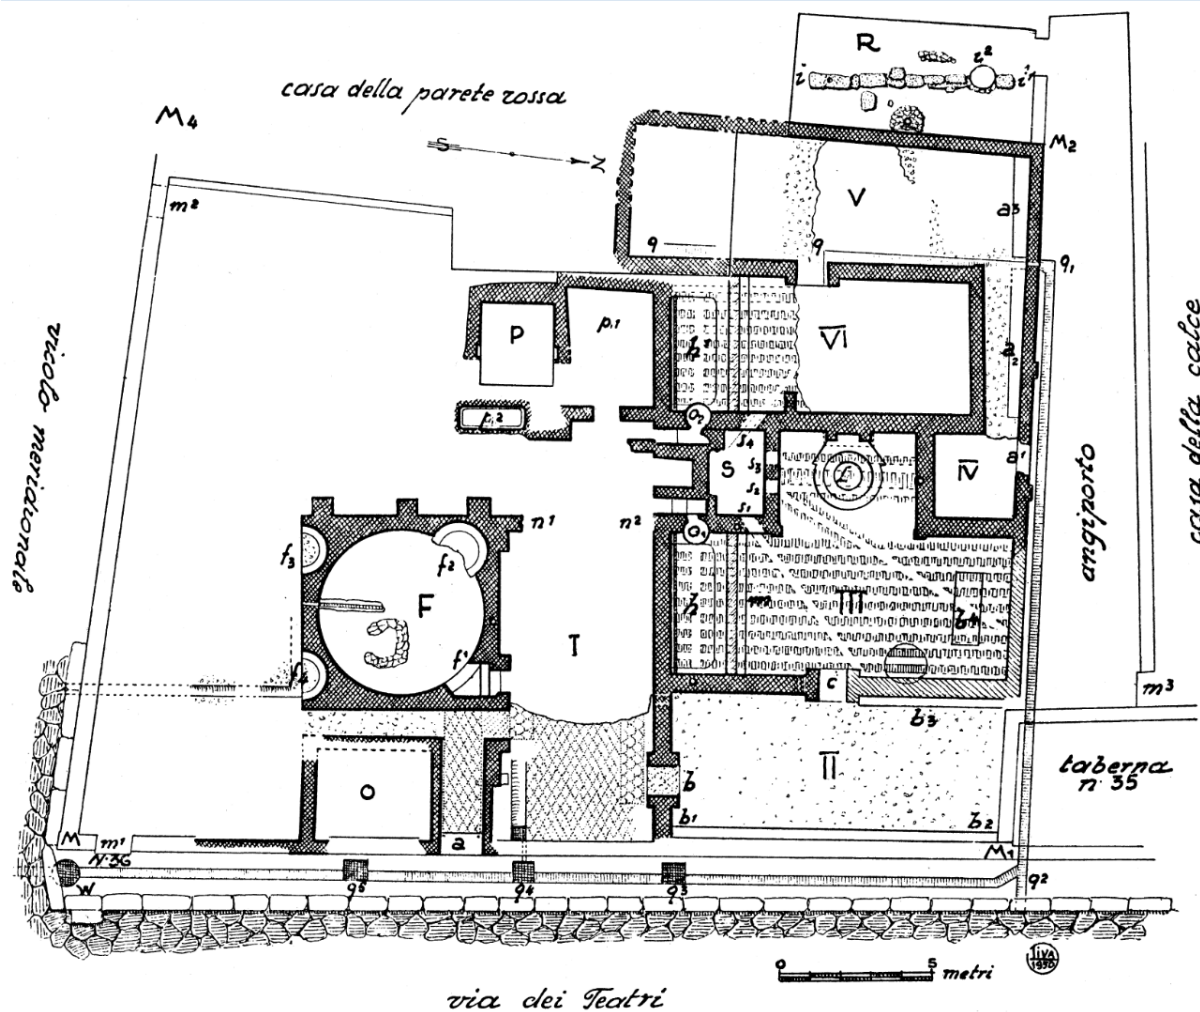
Fig. 4: Republican Baths, reconstructed plan of the baths; Maiuri 1950, 117 fig. 1

- In the original baths, the channel ran from the northeast corner of the women's apodyterium in the vicolo (fig. 4: room V) to the via dei Teatri. It is unknown, whether and how it was covered at this time because no original cover slabs remain.

The southwest part of the baths lot is blank on Maiuri's reconstructed plan of the baths (fig. 4). His "state plan" of the lot (fig. 8) shows hatched walls, assigned to the Imperial period house, and white structures, which he did not attribute to any specific phase and did not mention in his report. Assessment of this area is hindered by a large tree, located to the south of rooms 27/28, to the east of rooms 26/34 and to the north of room 39 (fig. 2). While we had cleaned parts of rooms 26-28 in 2015 and 2016, we did not fully understand the sequence of walls and structures. Since this area is crucial for assessing the original extension and layout of the baths, and for understanding the function and accessibility of the later garden peristyle section, cleaning was carried out in two rooms.

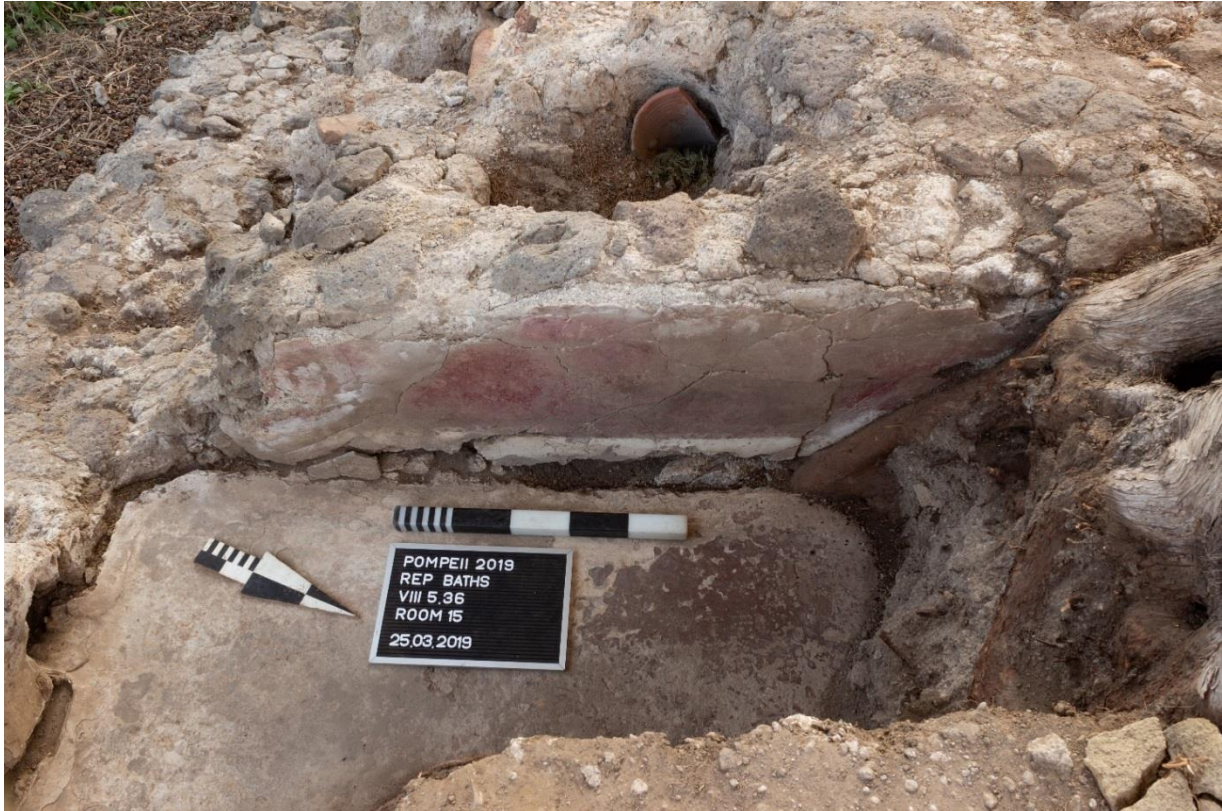
Fig. 5: Men's tepidarium, SW corner with drain and sinter deposits (© Topoi Project/FU Berlin)

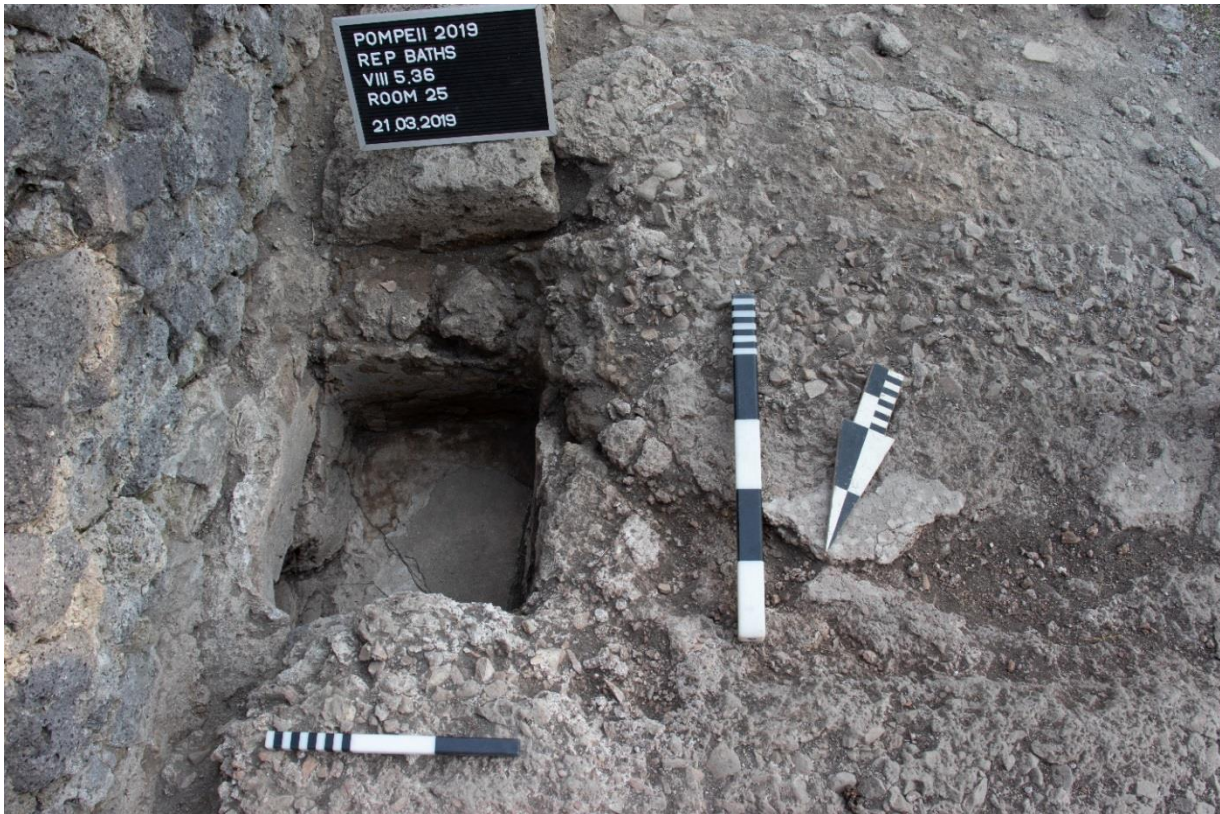
Fig. 6: Men's apodyterium, SE corner, drain and settling basin (© Topoi Project/FU Berlin)

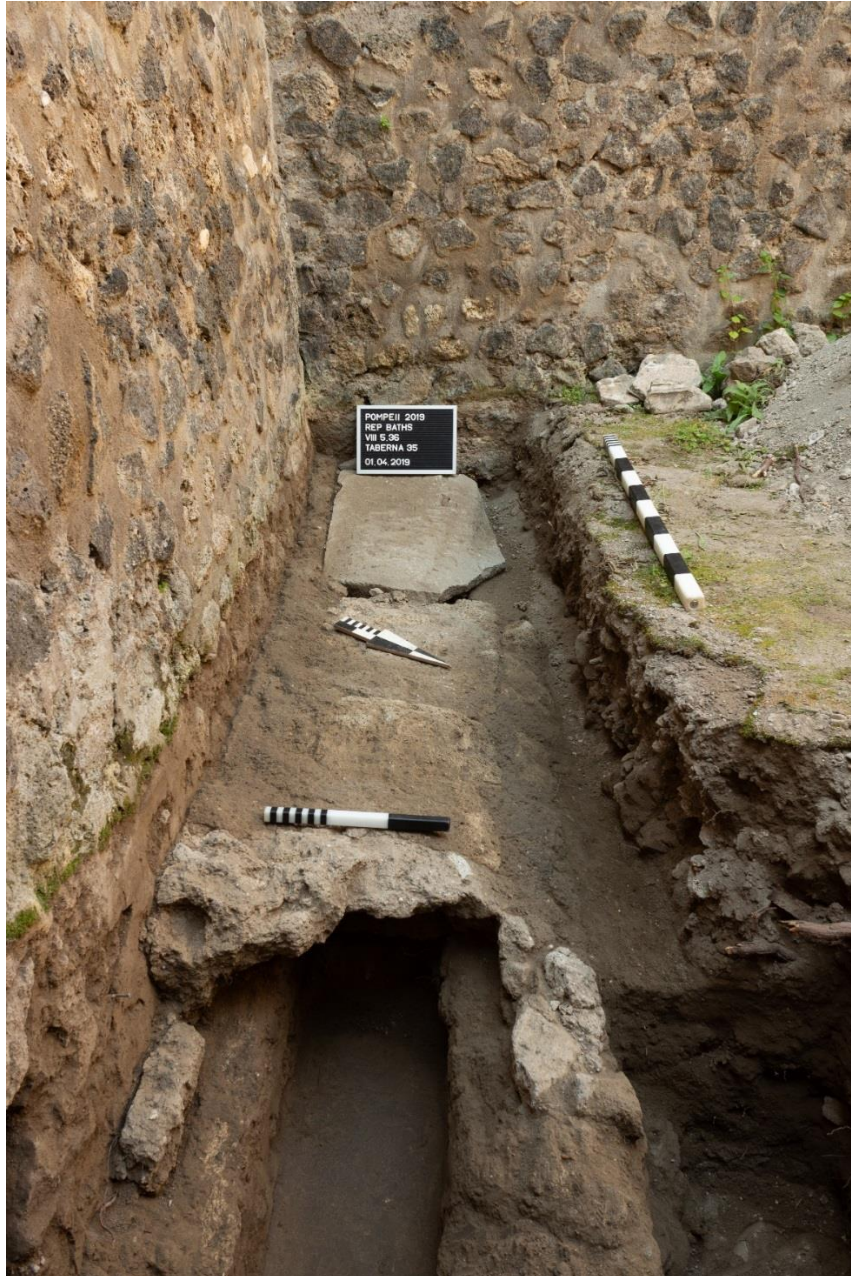
- In Taberna 35 of the Casa della Calce, the continuation of the drainage channel was cleaned that ran along the north façade of the baths (fig. 2: room/vicolo 1) and served to drain the water from the women's section. The channel was slightly narrower in Taberna 35 than in the vicolo and its covering slabs were also slightly different (fig. 7). While precise history of the channel cannot yet be fully reconstructed, cleaning this year confirms the following preliminary sequence:

- The channel was extended further west in the vicolo, to drain additional water from an unknown location/building to the west of the baths.
  - After the abandonment of the baths around 30/20 BC, the entire channel was covered by the southern porticus (paved with opus signinum) of the extended main northern peristyle of the Casa della Calce. It was still functioning because water from the main peristyle of this house was drained into this channel.

- When the Casa della Calce was remodeled after the earthquake of AD 62, the southern porticus of the main peristyle was abandoned and Taberna 35 was built. Since the south wall of the Taberna respects the channel, the latter was most likely still functioning at this time, draining water at least from the peristyle of the Casa della Calce.

Fig. 7: Taberna 35, drainage channel along the south wall (© Topoi Project/FU Berlin)

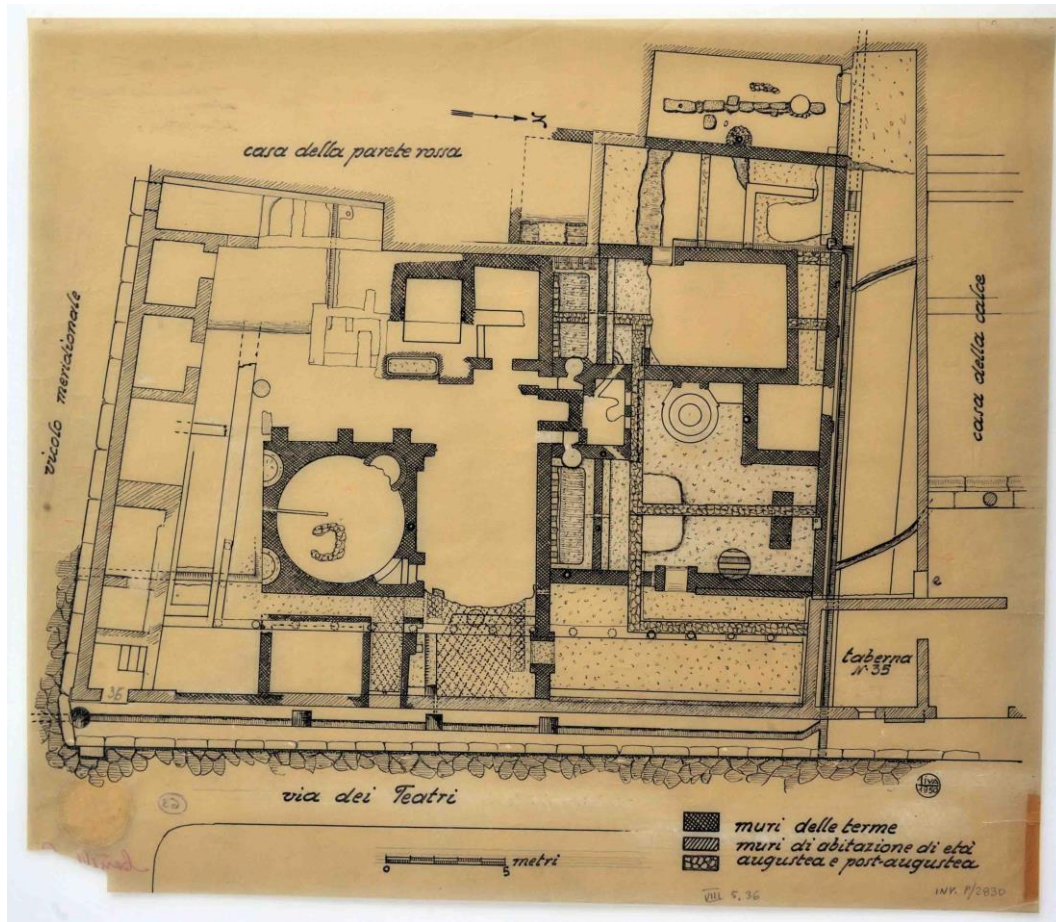
Fig. 8: State plan of the baths lot; Maiuri 1950, 134 fig. 11

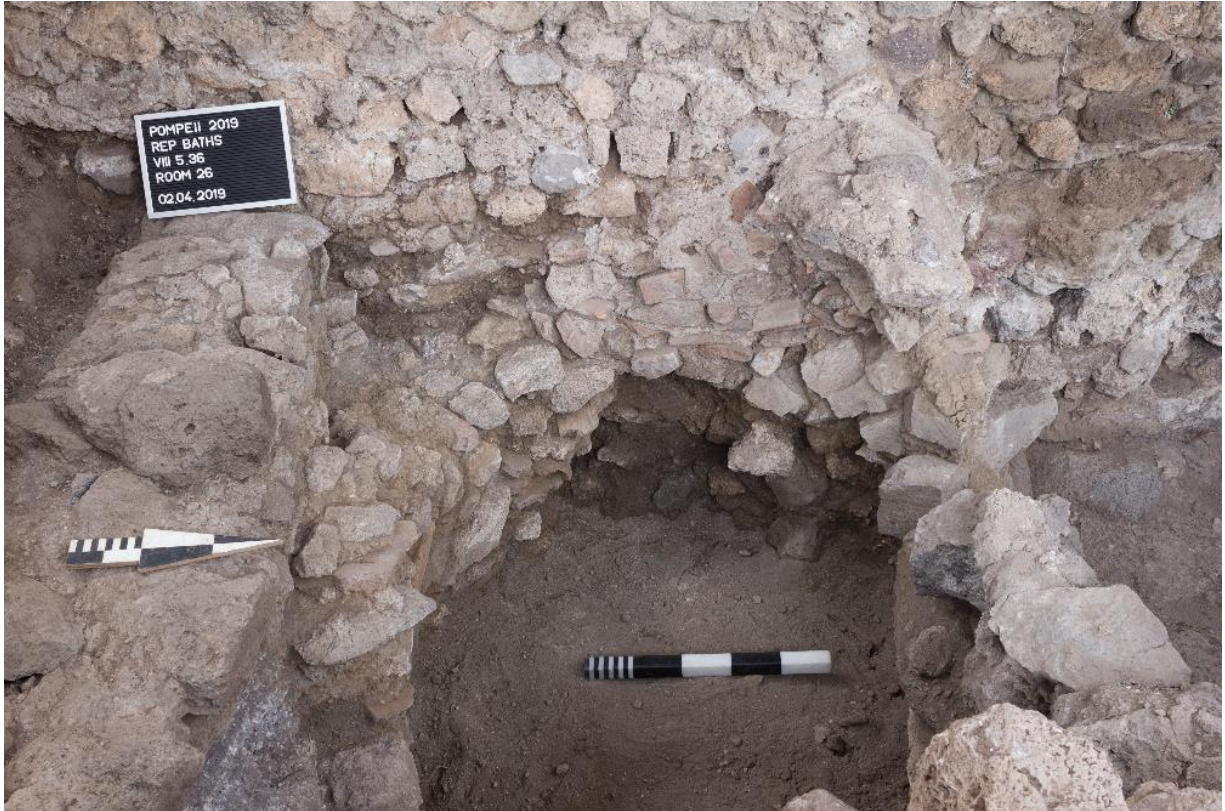
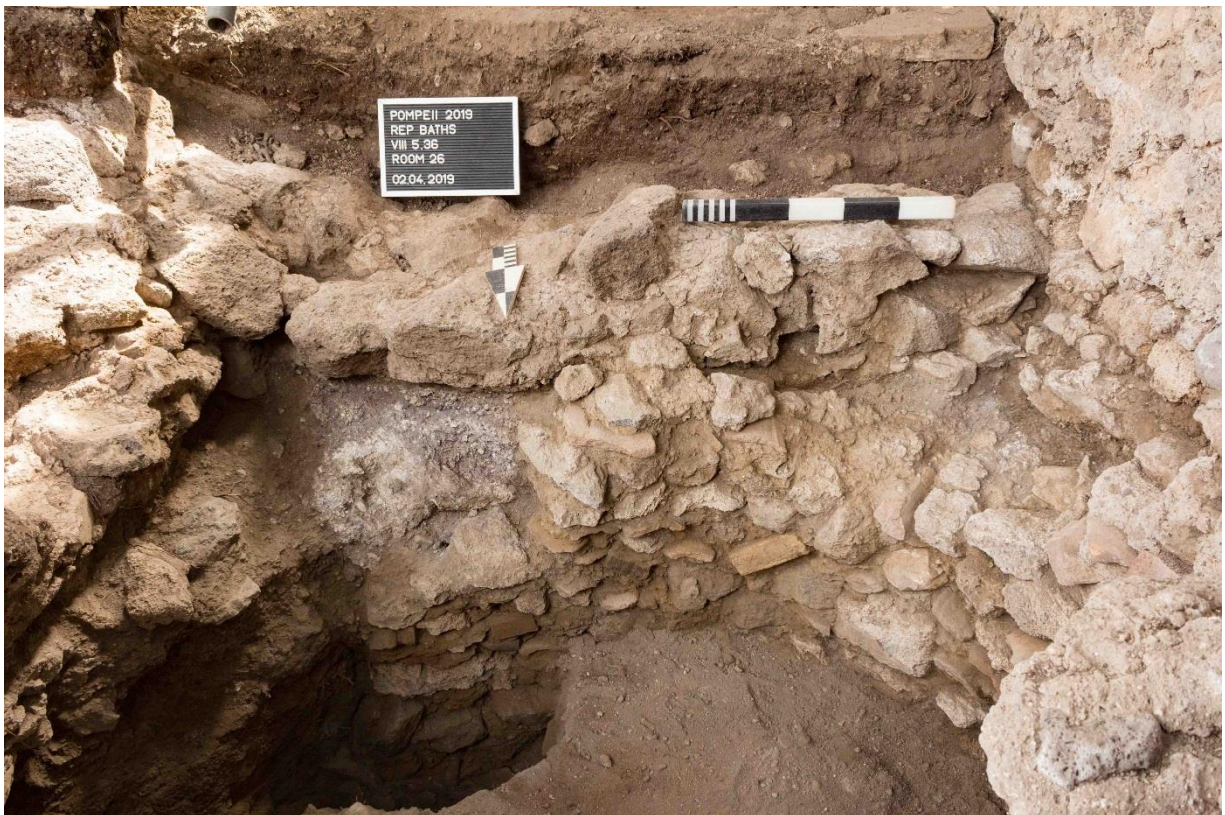
- Room 26 was fully cleaned, revealing first the well-like structure and channel that had been found and documented in 2015 (see report 2015). In addition, the structure in the southern part of the room, strangely rounded on Maiuri's plan, was cleaned and identified as remains of a limekiln (figs. 9-10). In agreement with Dottore Francesco Muscolino, responsible archaeologist for the Regio VIII of Pompeii, cleaning was extended into a small trench here, in order to better understand the remains. The kiln had been destroyed in antiquity and was found filled with construction debris, which included many fragments of Sigillata and Ceramica Comune, dated to the 1<sup>st</sup> c AD (US 2). Its southwest part is best preserved, clearly set against the ("double") west wall of room 26 (see below). In contrast, the relationship between the kiln and the south and east walls of room 26 cannot be fully assessed because the above-mentioned tree prevents full excavation and neither wall could be excavated down to its foundation. The south wall abuts the decorated west wall, however. Currently, the following sequence can be reconstructed.

- West wall of rooms 26/34, covered with Second Style painting (see below, room 34) when the garden peristyle was built.
  - Limekiln, installed for repairs on site: e.g., when the garden peristyle section was remodeled or for repairs after the AD 62 earthquake.

- Destruction of the limekiln that was no longer needed; filled with debris/ building waste; sometime before AD 79.

Fig. 9: Room 26, limekiln (© Topoi Project/FU Berlin)

Fig. 10: Room 26, limekiln (© Topoi Project/FU Berlin)

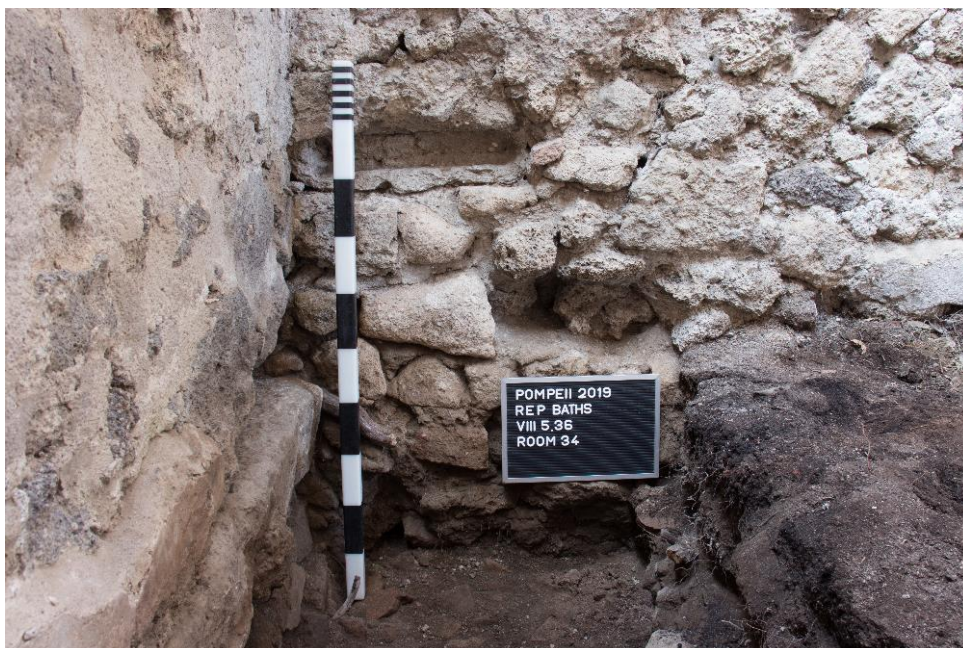
- A latrine was built along the southern wall. The cavity for a wooden seat is visible in the west wall, next to the southwest corner (fig. 11). The latrine may have been built when the garden peristyle section was transformed, sometime in the early Imperial period (see above). Room 34, unfavorably located in the unlit southwest corner of the garden peristyle section, was obviously the most appropriate location for a latrine.

- The latrine was destroyed and the entire room was filled with debris/ demolition material. This happened most likely after the earthquake of AD 62 when the entire garden peristyle section was transformed into a quarry (for volcanic ash) and building yard (both to extract reusable building material and to deposit rubbish).

Fig. 11: Room 34, latrine in SW corner, from east (© Topoi Project/FU Berlin)

- The southern part of room 34 was cleaned in order to study the complicated sequence of walls. While Maiuri had excavated this room, he did not attribute any of its features and walls to the baths and therefore did not discuss it any further in his report (Maiuri 1950). The cleaning significantly clarified the situation and suggests the following development:

- The south, east and west walls were built for the baths (whether for the original baths or later, needs further study). The south wall includes a threshold, suggesting that room 34 served as a service corridor, accessible from the southern street (vicolo delle Pareti Rosse). The service corridor led to the area around the deep well (fig. 2: room 23) and the praefurnium (fig. 2: rooms 16-17). The west wall of room 34 (and 26) is a kind of “double” wall, but the eastern part of this double wall (visible in rooms 26 and 34) extends only to a height of about 1.70 m above the floor; this correlates with the top of a vault/cover of an adjacent large cistern in the Casa delle Pareti Rosse. Therefore, the west wall of rooms 26 and 34 served as a retaining/supporting wall or reinforcement, to act against the pressure of the adjacent large cistern.

- The door in the south wall was blocked, and the entire room decorated with Second Style wall painting. This occurred after the abandonment of the baths, when the owner of the Casa della Calce transformed the lot of the baths into a garden peristyle.

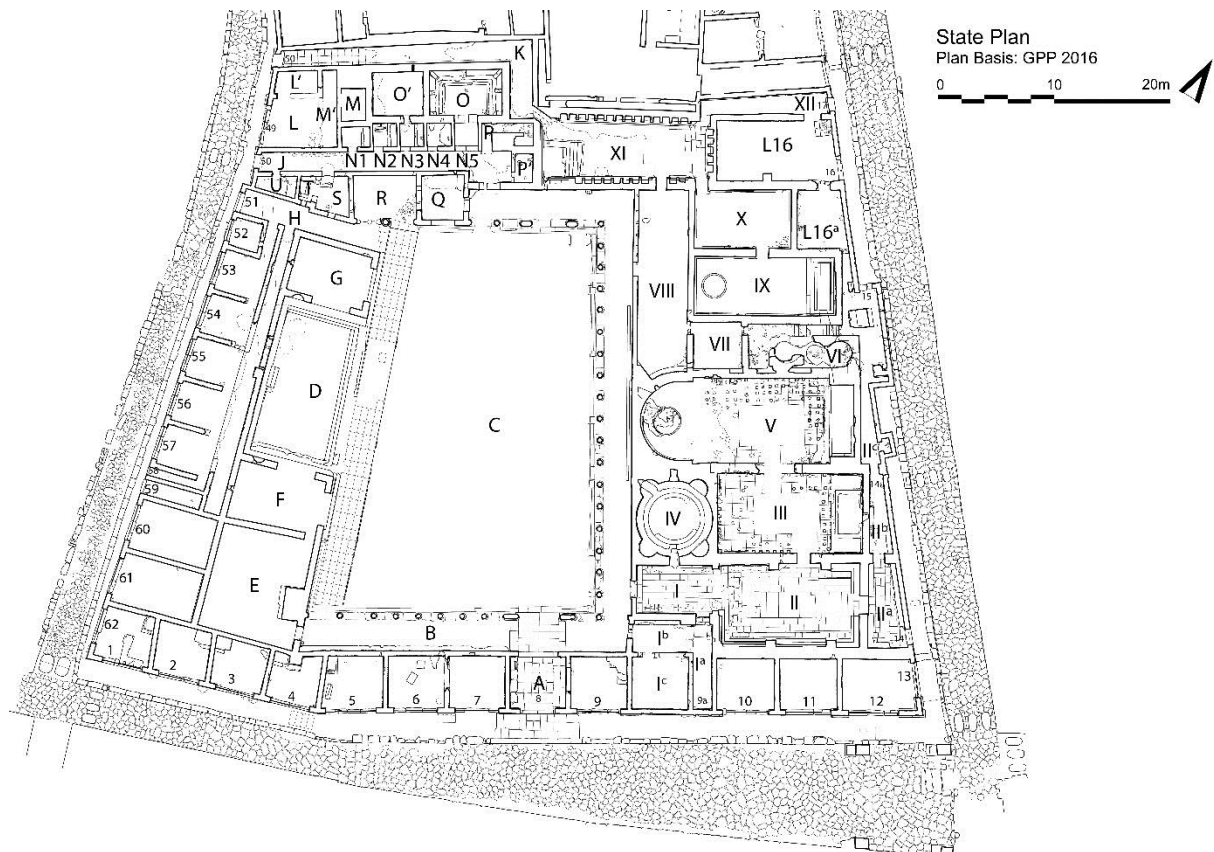
Fig. 12: Stabian Baths, plan with numbering system (© Topoi Project/FU Berlin)

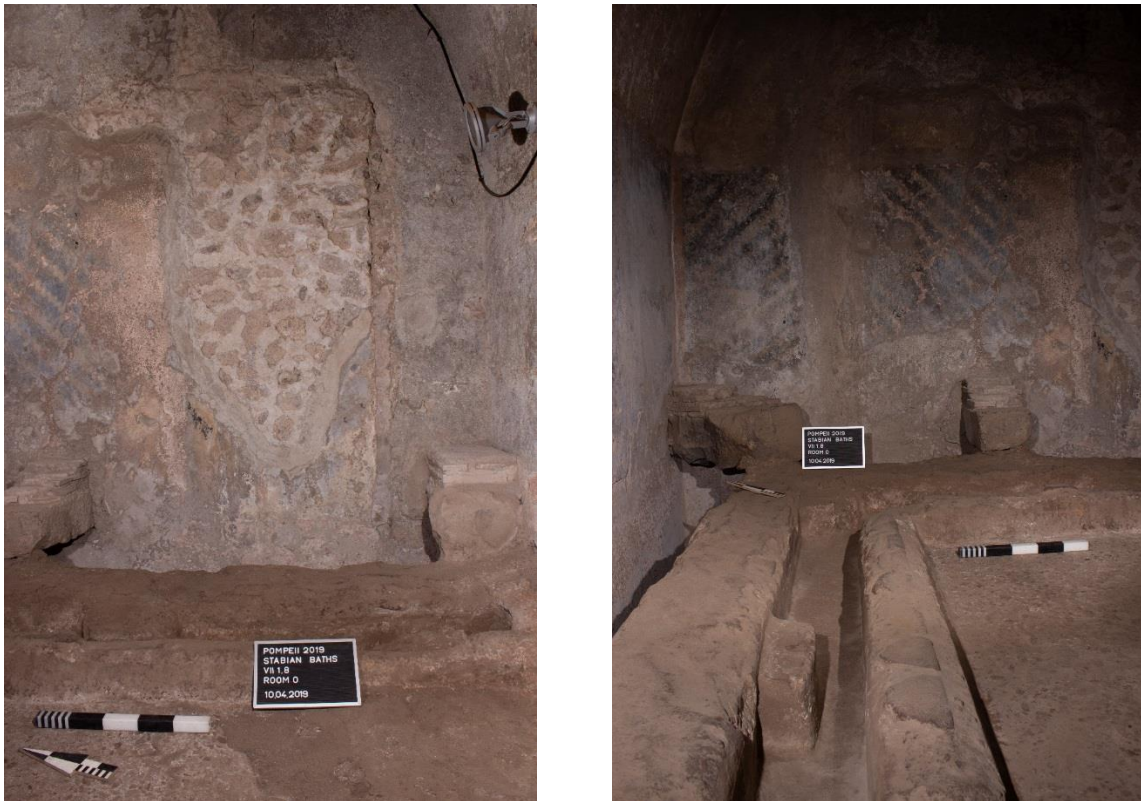
- The pavement and channels of the large latrine O were fully cleaned and documented (fig. 13). The plan and chronology of water management features (supply, drainage) in the latrine is more complicated than suggested in Eschebach's publication (Eschebach 1979) and requires further study and contextualization within the water management system of the Stabian Baths.

Fig. 13: Stabian Baths, latrine O (© Topoi Project/FU Berlin)

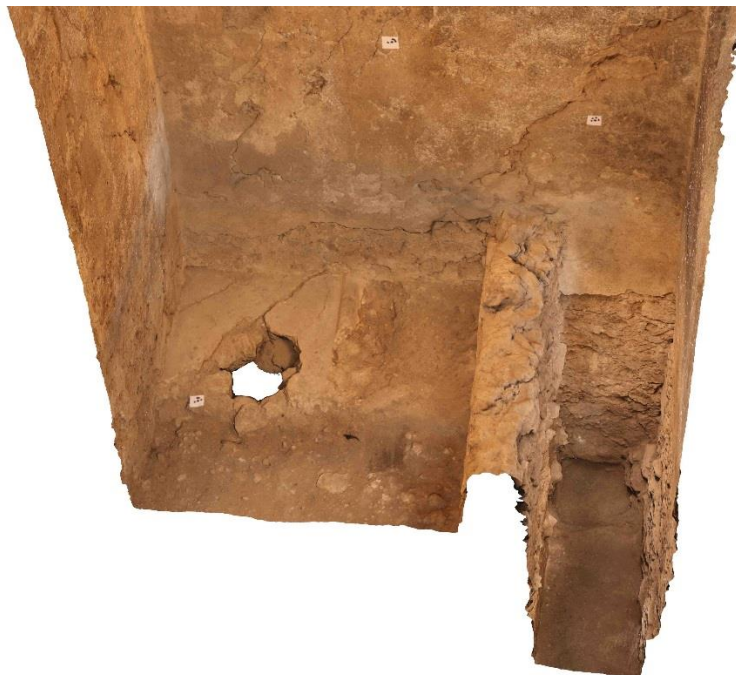
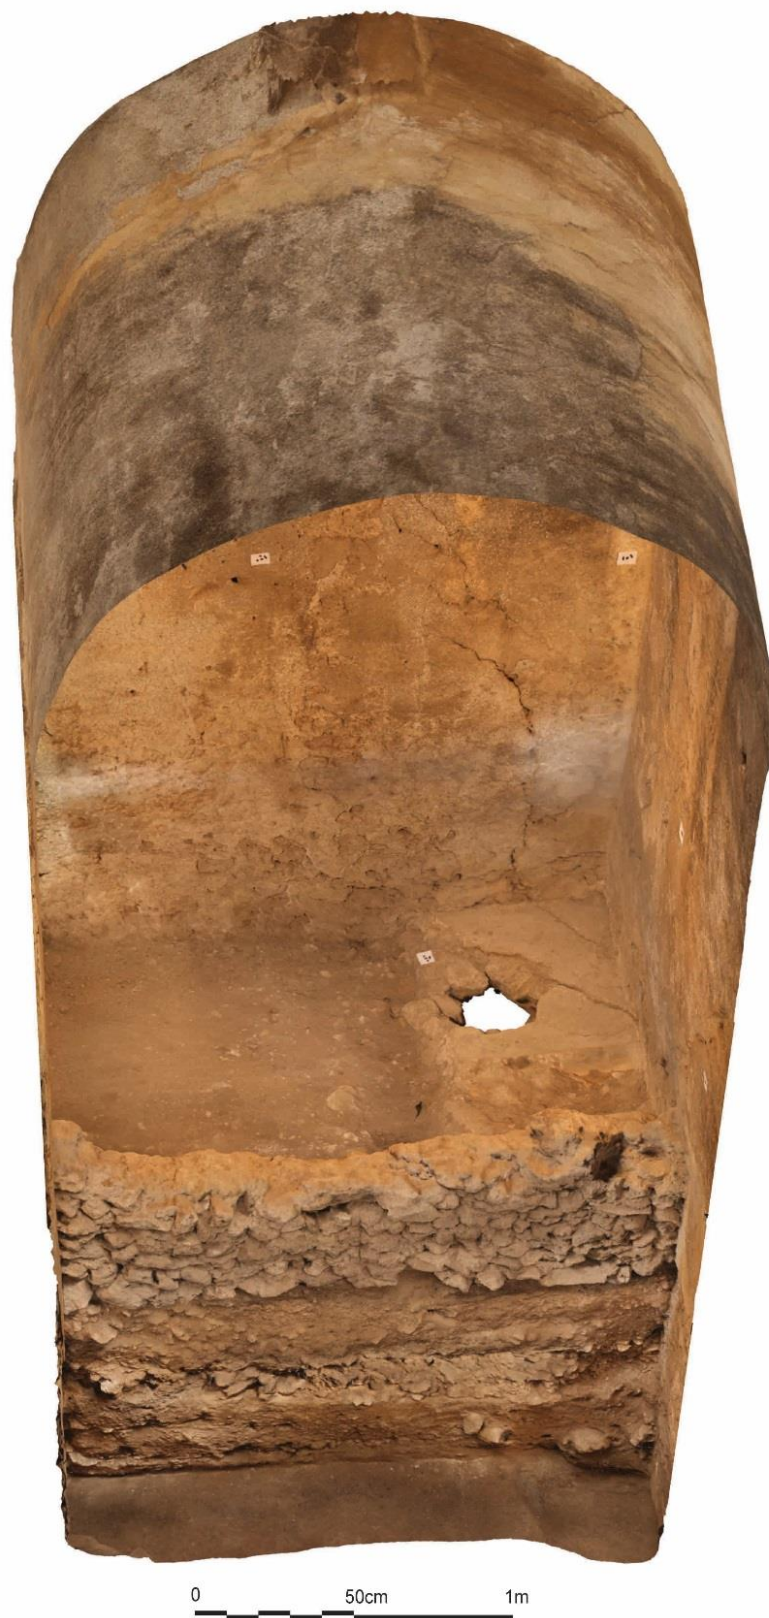
- SFM models were made of rooms N1 and N2, which could not be done in 2016, when both were being excavated. The restricted space, the depth of the “bathtubs” and the very limited lighting of these rooms make it difficult to take photos. These models show in an exemplary manner the full stratigraphic sequence in the narrow “bathtub spaces” (figs. 14-15).

Fig. 14: Stabian Baths, N2, SFM model, view from south (© Topoi Project/FU Berlin)

Fig. 14: Stabian Baths, N2, SFM model, view from east with stratigraphic sequence in the “bathtub”  
(© Topoi Project/FU Berlin)
