## **BATHING CULTURE AND THE DEVELOPMENT OF URBAN SPACE CASE STUDY POMPEII**

The fifth excavation campaign in the Stabian Baths took place from May 30 to June 24, 2022, in a collaboration between the Freie Universität Berlin and the Università degli Studi di Napoli L'Orientale. It was generously funded by the German Research Foundation (DFG).

The fifth excavation campaign in the Stabian Baths aimed to clarify the following remaining open questions: a) for the house, final clarification of the construction, development, and plan; b) for the baths, the development and function of the southern tabernae, which presumably belonged to the baths from the beginning.

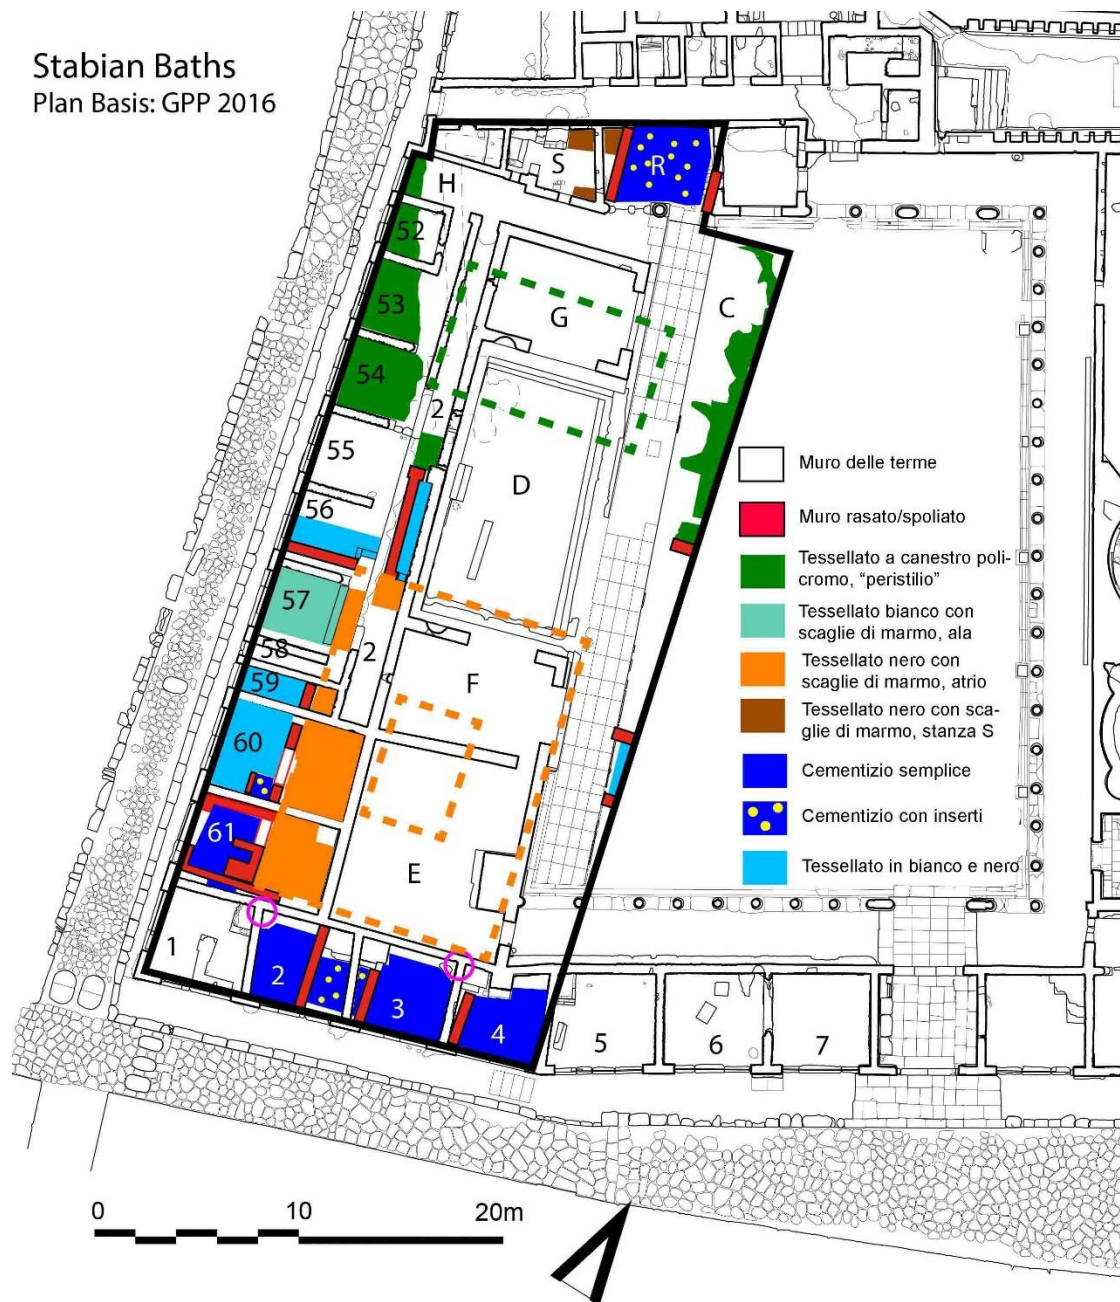
Fig. 2: Preliminary reconstruction of the house

In Areas XXII–XXVI and XXIX (fig. 1) we discovered razed walls and floors of six different rooms that belonged to the house. Combining these results with the findings from previous campaigns (fig. 1: Areas II, III, IX, XIV, XV, XVII–XXI) we can propose a preliminary reconstruction (fig. 2). This house had a surface area of ca. 900 m<sup>2</sup>, was organized axially symmetrically, and included an atrium and an open space that was possibly a peristyle courtyard. The house was richly decorated with lavish floors and probably also figurative wall decoration of Second Style of which we have found some fragments (fig. 3).

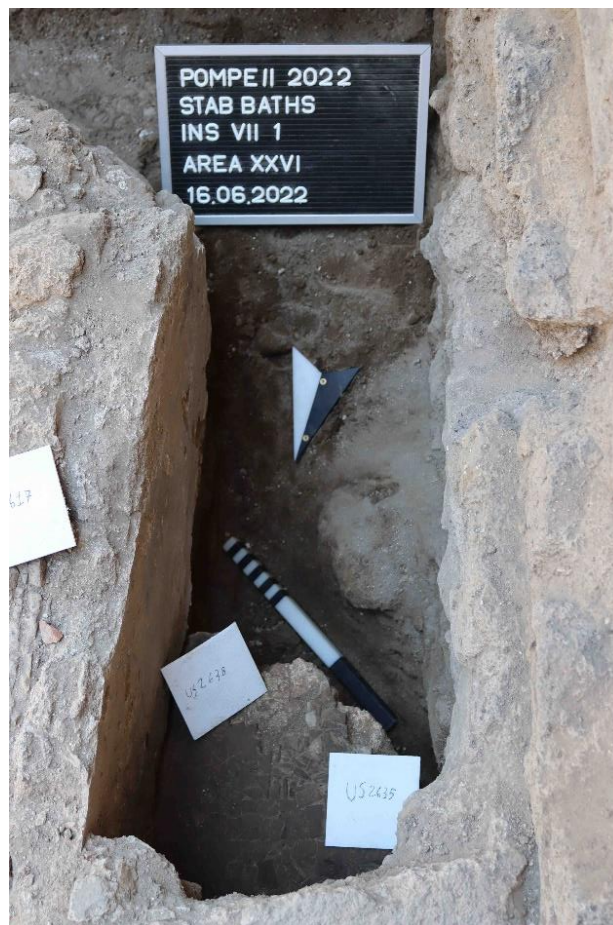
Fig. 4: Area XXVI: two pavements of the vestibule of the house (US 2635 = lower floor; upper floor = at lower border of photo)

- A centrally located vestibule to the south of the atrium (fig. 1: below tabernae 2 and 3, Areas XX, XXVI) was first equipped with a luxurious pavement made of irregularly cut tesserae of different colors; in a second phase, the level was raised and a new cement floor decorated with rosettes was made; this again was later embellished with pieces of different types of marble (fig. 4).

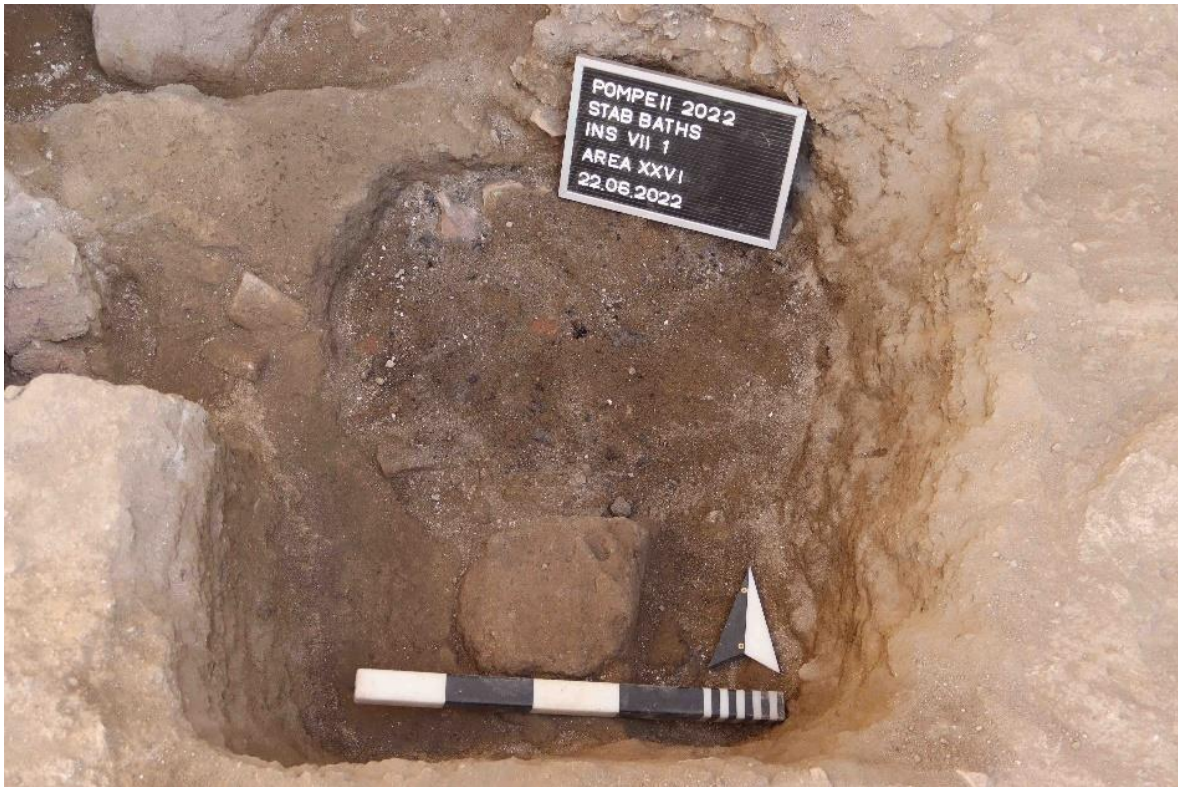
Fig. 5: Area XXVI: deposit under the original floor of the house

- The vestibule was flanked by three or four rooms decorated with cement floors, none of which can be securely identified as a taberna (fig. 1: under tabernae 1–4, Areas XV, XVIII, XX, XXVI). The room under taberna 3 (Area XXVI) provided two levels of cement floors and under the original floor traces of a possible votive foundation deposit (fig. 5).

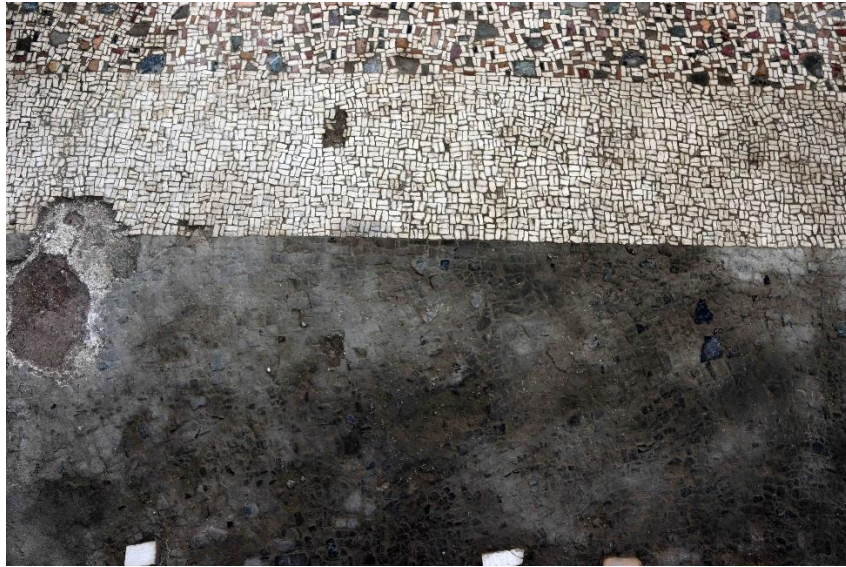
Fig. 6: Area XXV: pavement of the atrium (bottom); threshold (center); pavement of the ala (top)

- The atrium was very large, with a length of 15.50 m (north-south), while the width cannot be securely determined; however, if the rooms to the west and east of the atrium had a similar east-west extension, the atrium would have been ca. 12–12.50 m wide (east-west). In the local context, this is a remarkable size: among the currently largest known atria are those of the Casa delle Nozze d'Argento (V 2, i) with 16.46 x 11.92 m and of the Casa dei mosaici geometrici (VIII 2, 16) with 14.58 x 9.28m. The atrium was decorated with a tessellatum pavement, made of black irregularly cut tesserae and decorated with pieces of different kinds of marble. We found this type of pavement under tabernae 57, 59, 60, 61 and corridor 2 (fig. 1: Areas XXV, XVII-XIX, XXII; fig. 6). The impluvium must have been under today's rooms E and F of the baths.

- The atrium was flanked by three cubacula and an ala to the west and most likely also to the east; moving from south to north, the floors of these rooms became increasingly lavish and included a simple cement floor (under taberna 61, Area XVIII), black-and-white tessellatum mosaics with regularly cut tesserae (under tabernae 59 and 60, Areas XVII, XIX) and a tessellatum floor with irregularly cut white tesserae and large pieces of different colors (under taberna 57, Area XXV, fig. 6, 7).

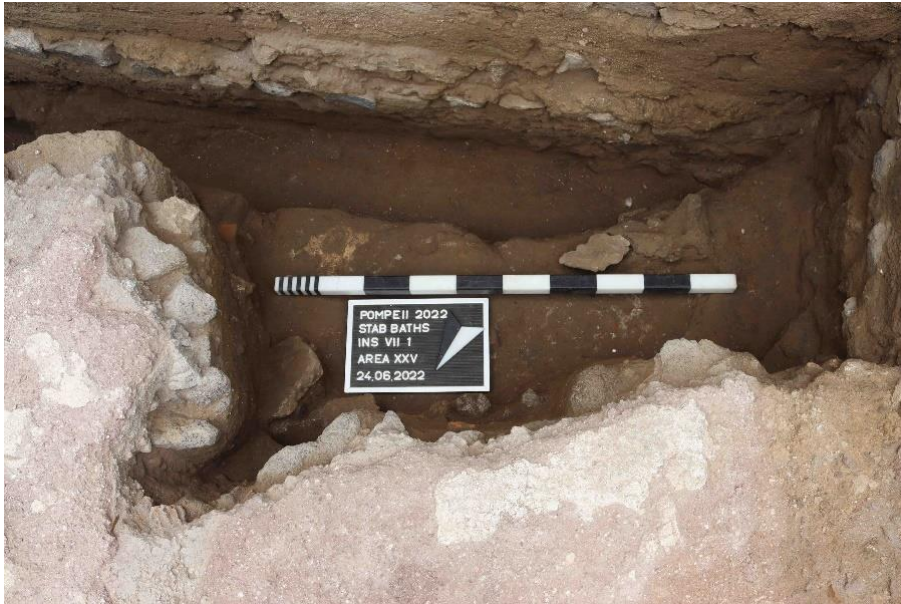
Fig. 8: Area XXV, taberna 57: remains of walls of Sarno limestone (under the measure)

- A wall of Sarno limestone blocks was found under the ala (Area XXV, taberna 57), which ran in an east-west direction and was oriented like the later walls of the house and baths (fig. 8). This wall may have been built before the construction of the baths (after 130/125 BC) and is therefore one of the few remains of an earlier building that we have discovered so far on the Stabian Baths site. It is possible that an earlier (private) building existed on the site of the Late Republican house that must have been respected during the construction of the baths and may explain the unusual L-shaped plan of the early baths (fig. 9).

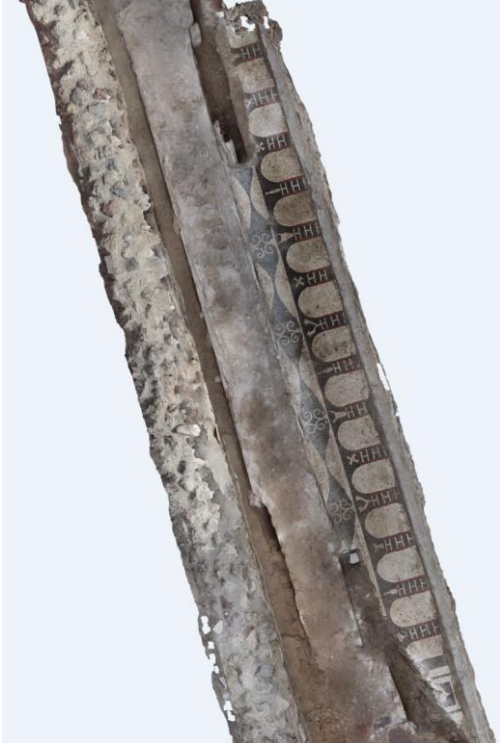
Fig. 10: Area XXII: orthophoto, razed west wall and pavement of the tablinum

- To the north of the atrium was a tablinum with a polychrome tessellatum floor (small, regularly cut black, white and red tesserae), richly decorated with 15 arches that has few comparisons in Pompeii (Area XXII, corridor H'; fig. 10). To the west of the tablinum was a large triclinium with another tessellatum pavement made of regularly cut small black and white tesserae of which we have only excavated the southern limit (Area XXIX, taberna 56; fig. 11).

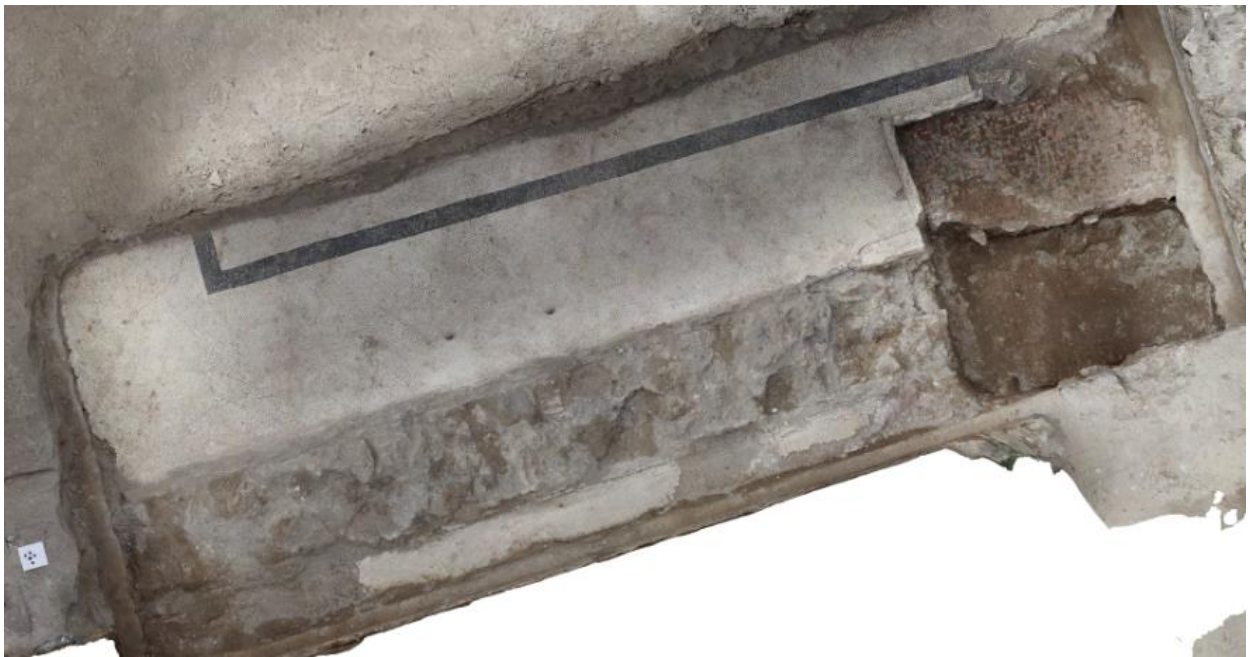
Fig. 11: Area XXIX, taberna 56: orthophoto, razed south wall, tessellatum pavement, and decorated threshold of a triclinium; to the south of the razed wall remains of the ala pavement

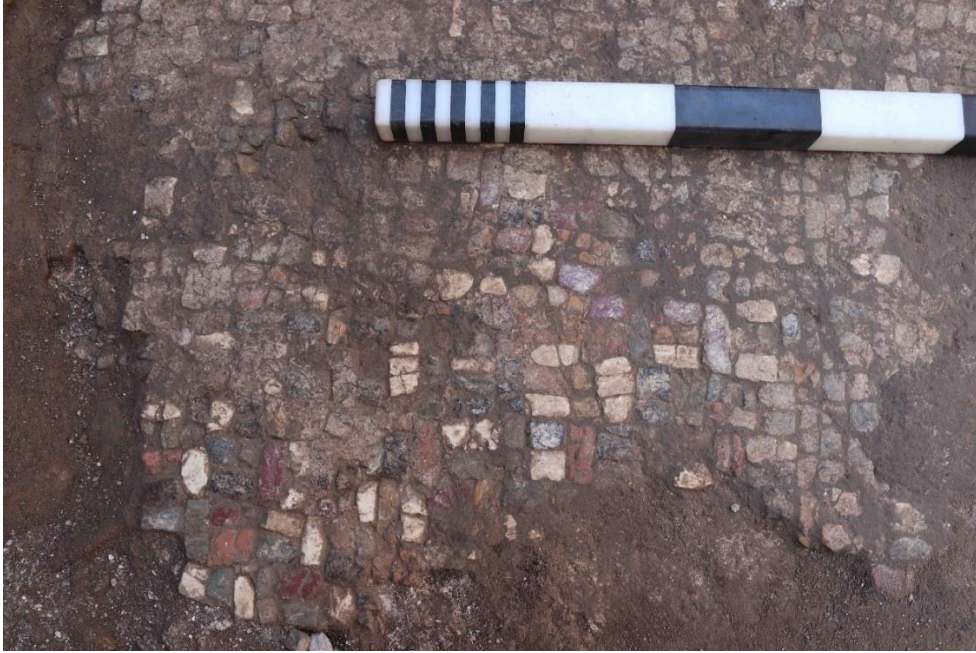
Fig. 12: Area XXIII, taberna 52: detail of West portico pavement

- The porticoes of the potential peristyle were very wide (at least 4 m) and all had a tessellatum floor with large, relatively regularly cut pieces of four different colors (red, yellow, green, white; figs. 12–13). Traces of this pavement were found this year in Areas XXII–XXIV (corridor H', tabernae 52 and 53) and in past years in Areas II, IX and XXI (palaestra, taberna 54). No traces have yet been found of the peristyle proper, except for the fluted drum of a column found in 2017 deposited in a trench under corridor H; this drum is made of fine gray tuff and covered with white plaster.

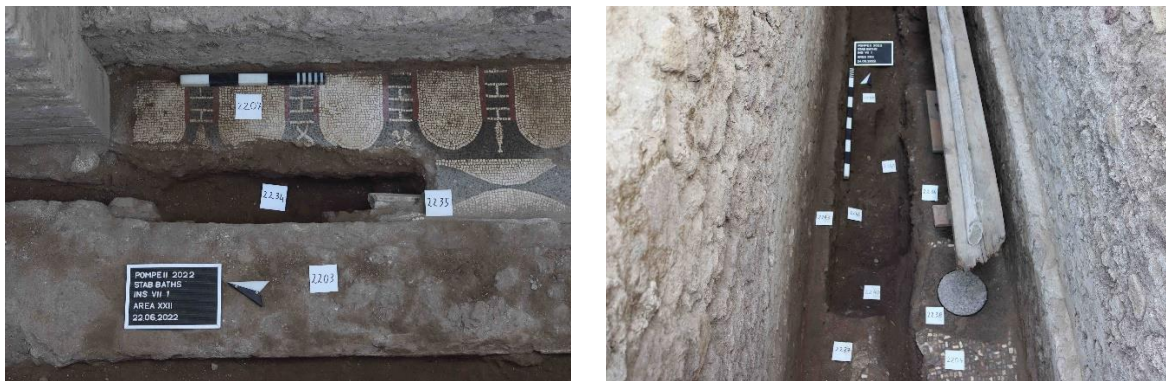
Fig. 14: Area XXII, corridor H': lead pipes of the house (phase 2) and baths (phase 4b)

- Corridor H' (Area XXII) revealed not only three different floors of the atrium, tablinum, and peristyle courtyard, but also evidence of a modernization phase of the house and a repair phase of the baths shortly before the eruption of Vesuvius (baths phase 4b). In the early Imperial period the house was provided with a water pipe that fed a fountain in the impluvium of the atrium. The lead pipe was laid in a narrow trench that had been cut into the floors of the peristyle, tablinum, and atrium; remnants of the pipe are preserved in the tablinum (fig. 14). The decoration visible today (US 2235) west of the row of arches (US 2207) dates to this phase and was made after the pipe was laid. After the house had been abandoned in AD 62, the lead pipe was partially torn out for reuse. This is evidenced by the robbed-out trenches in the northern area of the tablinum and in the southern portico of the peristyle (US 2234, 2240). A lead pipe was found 20cm above the floor of the peristyle, which must have been intended to supply the natatio and nymphaea of the baths after AD 62. However, the pipe terminates in the center of corridor H', just north of a potential centrally placed supply line to the natatio. Consequently, at the time of the eruption of Vesuvius, the pipe was not finished or under repair. The fact that the baths had to be repaired immediately before the eruption and did not function has already been demonstrated elsewhere in the building with similar findings.

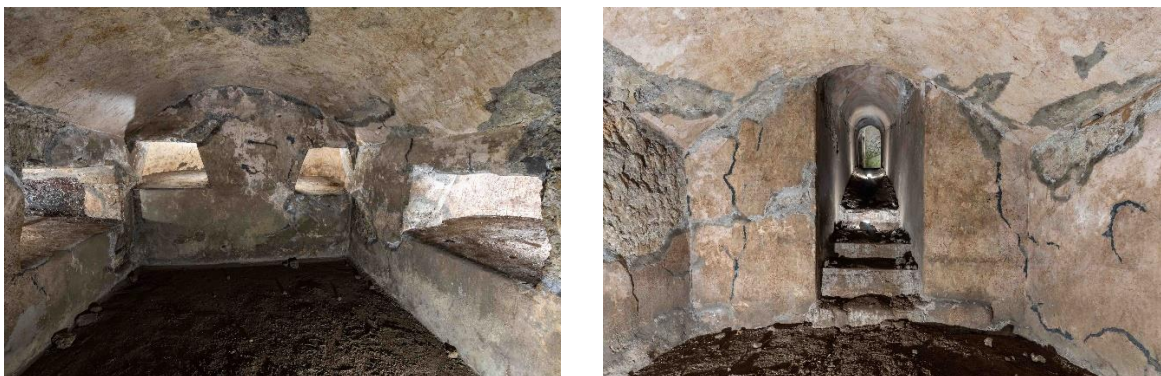
Fig. 15: Cellar under the northern part of the house (left) with access corridor (right); ©Mauro Palumbo

- While the east and west porticoes of the peristyle did not serve any rooms, two richly decorated rooms and a large underground cellar (long misidentified as an Etruscan or Archaic tomb, fig. 15) opened onto the northern portico.

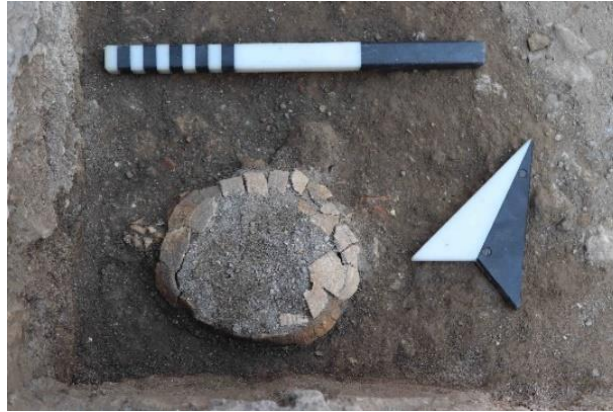
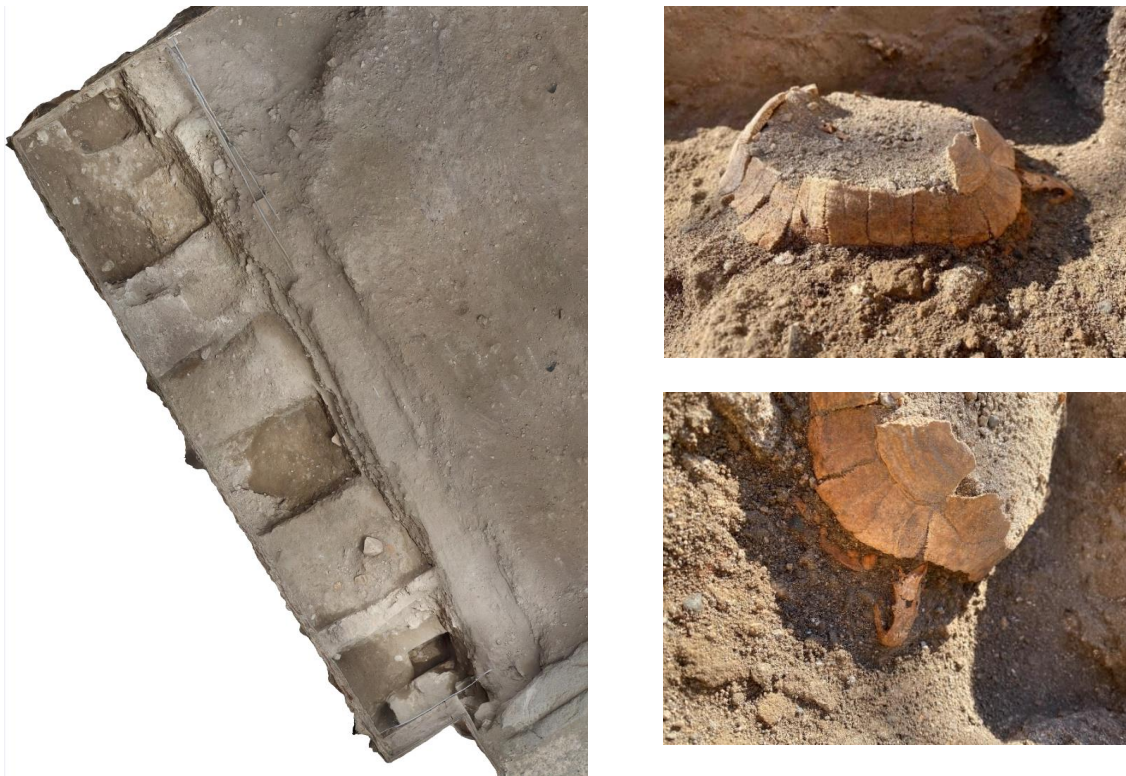
Fig. 16: Area XXVII, taberna 6: orthophoto at the end of excavation (left); turtle (above and right)

A turtle, pregnant with a single egg, was found between the two lowest of these beaten-earth floors. Several artisanal installations of unknown function were found in the northern and southern part of the trench (fig. 16).

Three ancient beaten-earth floors could be identified, at the levels of 24.26 MASL, 24.36 MASL, and 24.63 MASL. Diagnostic finds provide a terminus post quem of the early Imperial period for the upper two floors while the lowest belongs to the first phase of the baths.

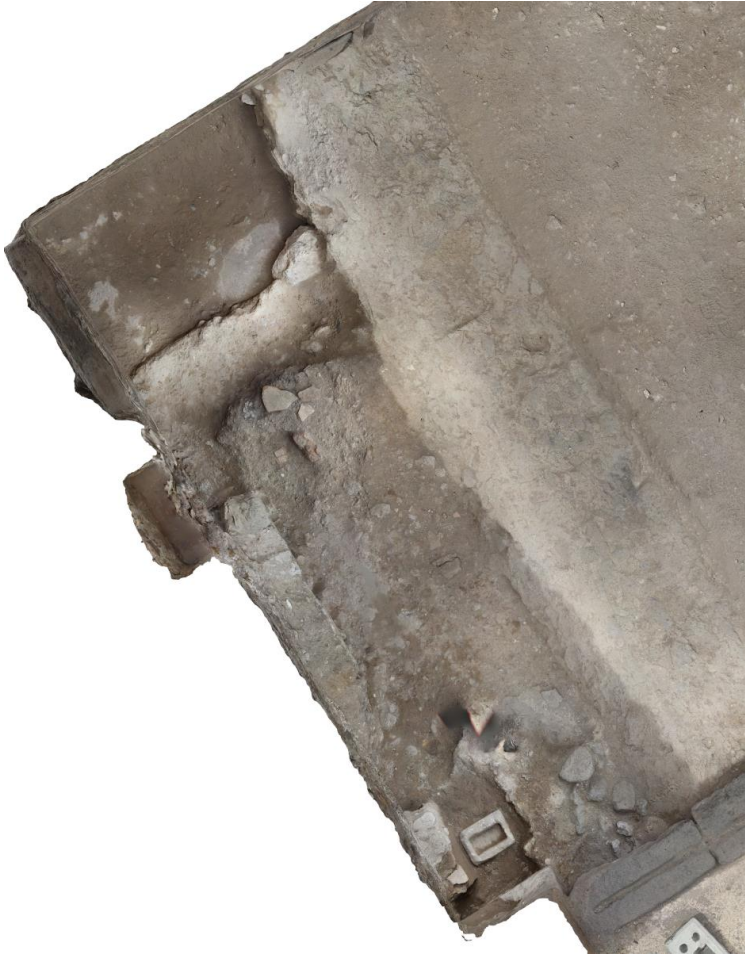
Fig. 17: Area XXVIII, taberna 7:  
orthophoto at the end of excavation

In the center of taberna 7, the large drainage channel that ran from the latrine of the baths through the palaestra to the Via dell'Abbondanza was excavated (fig. 17); it was covered with a vault of caementitium which in previous excavations has been attributed to the channel's construction phase in the early Imperial period. To the west of the canal we uncovered several floor levels that preceded the construction of the channel. In the southwest corner was a

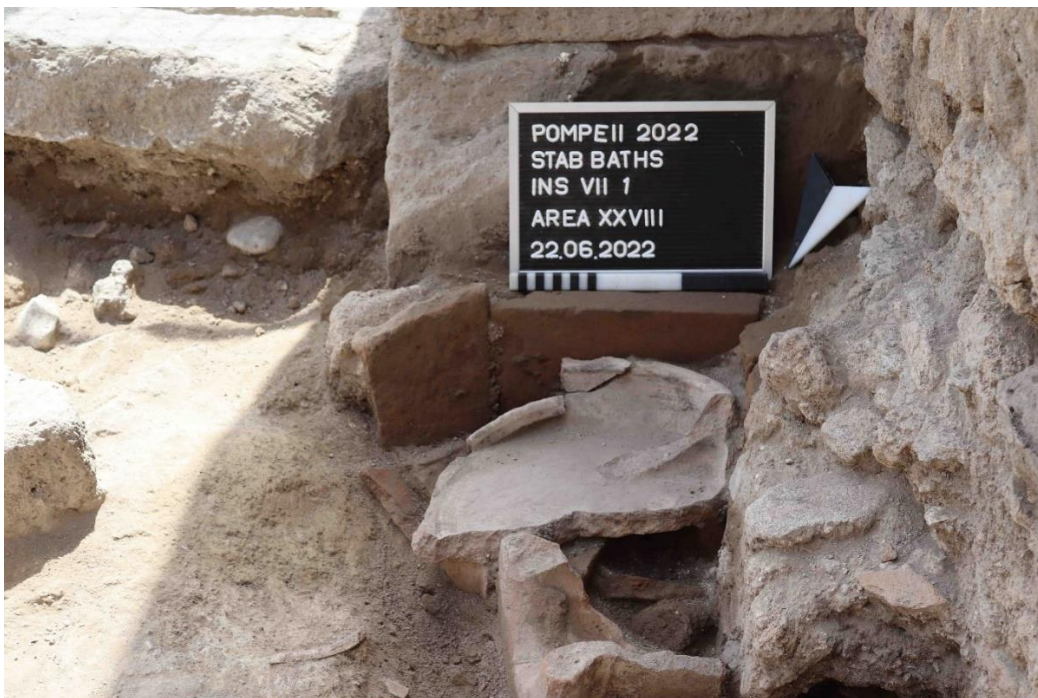
Fig. 18: Area XXVIII, taberna 7: vessels stacked on top of each other in southwest corner

structure containing several vessels that were stacked on top of each other, included ash, and show abundant traces of burning (fig. 18).

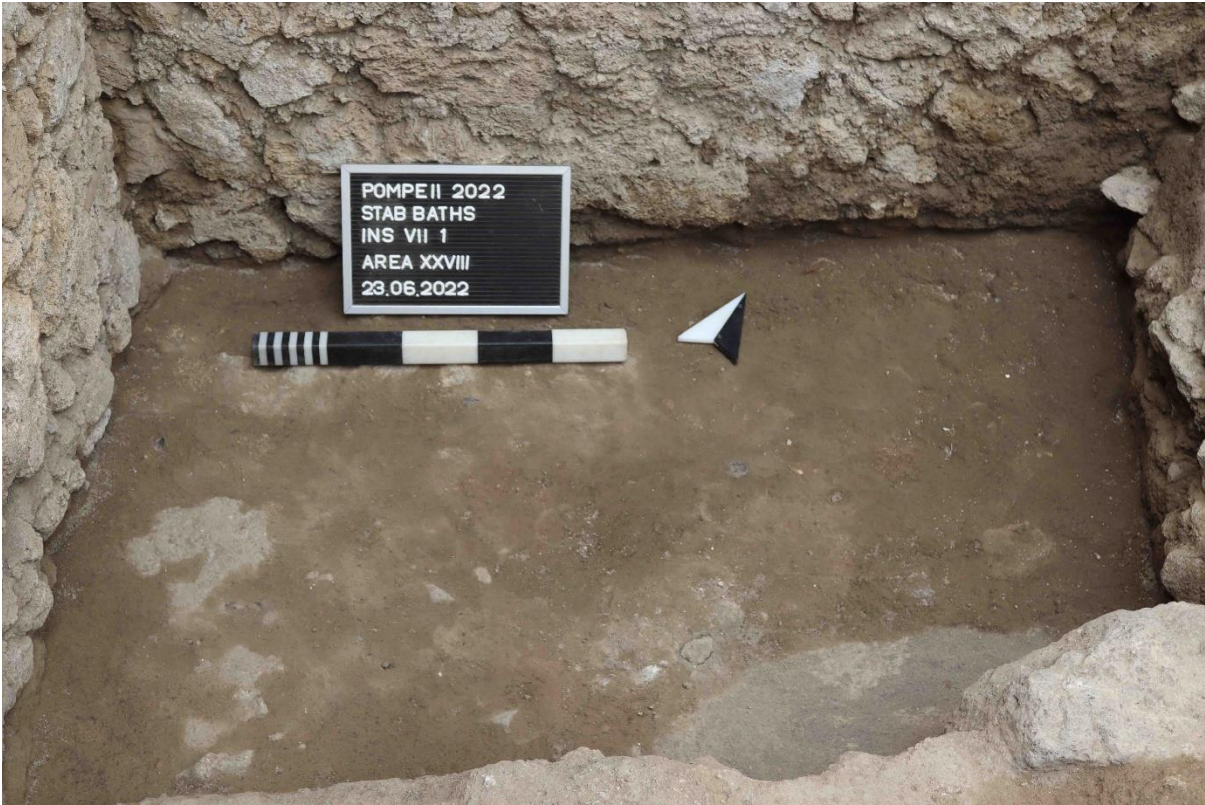
Fig. 19: Area XXVIII, taberna 7: earth mortar under north and west walls

Investigation of tabernae 6 and 7 (fig. 1) revealed a complex stratigraphic sequence. In both tabernae, only the western third of the room was excavated. In both, the foundation of the west and north walls was reached, which rested on a foundation layer of earth mortar; the latter was 10–30cm wider than the walls themselves (fig. 19). We had found these characteristic earth mortar foundations in all previous campaigns under walls that can certainly be assigned to the first phase of the baths. The characteristic Nocera tuff pillars on the south facade of the tabernae rest on ashlar of Sarno limestone. While the pillars remained unchanged throughout the period of use of the tabernae, the thresholds were raised (probably several times) along with the level of the tabernae.
