GYMNASIUM OF AGRIGENTO REPORT OF THE 2022 SEASON

The first excavation campaign in the Gymnasium of Agrigento took place from September 12 to October 7, 2022. It was generously funded by the Ernst-Reuter-Gesellschaft der Freien Unversität Berlin, the Freie Universität Berlin, and the Politecnico di Bari.

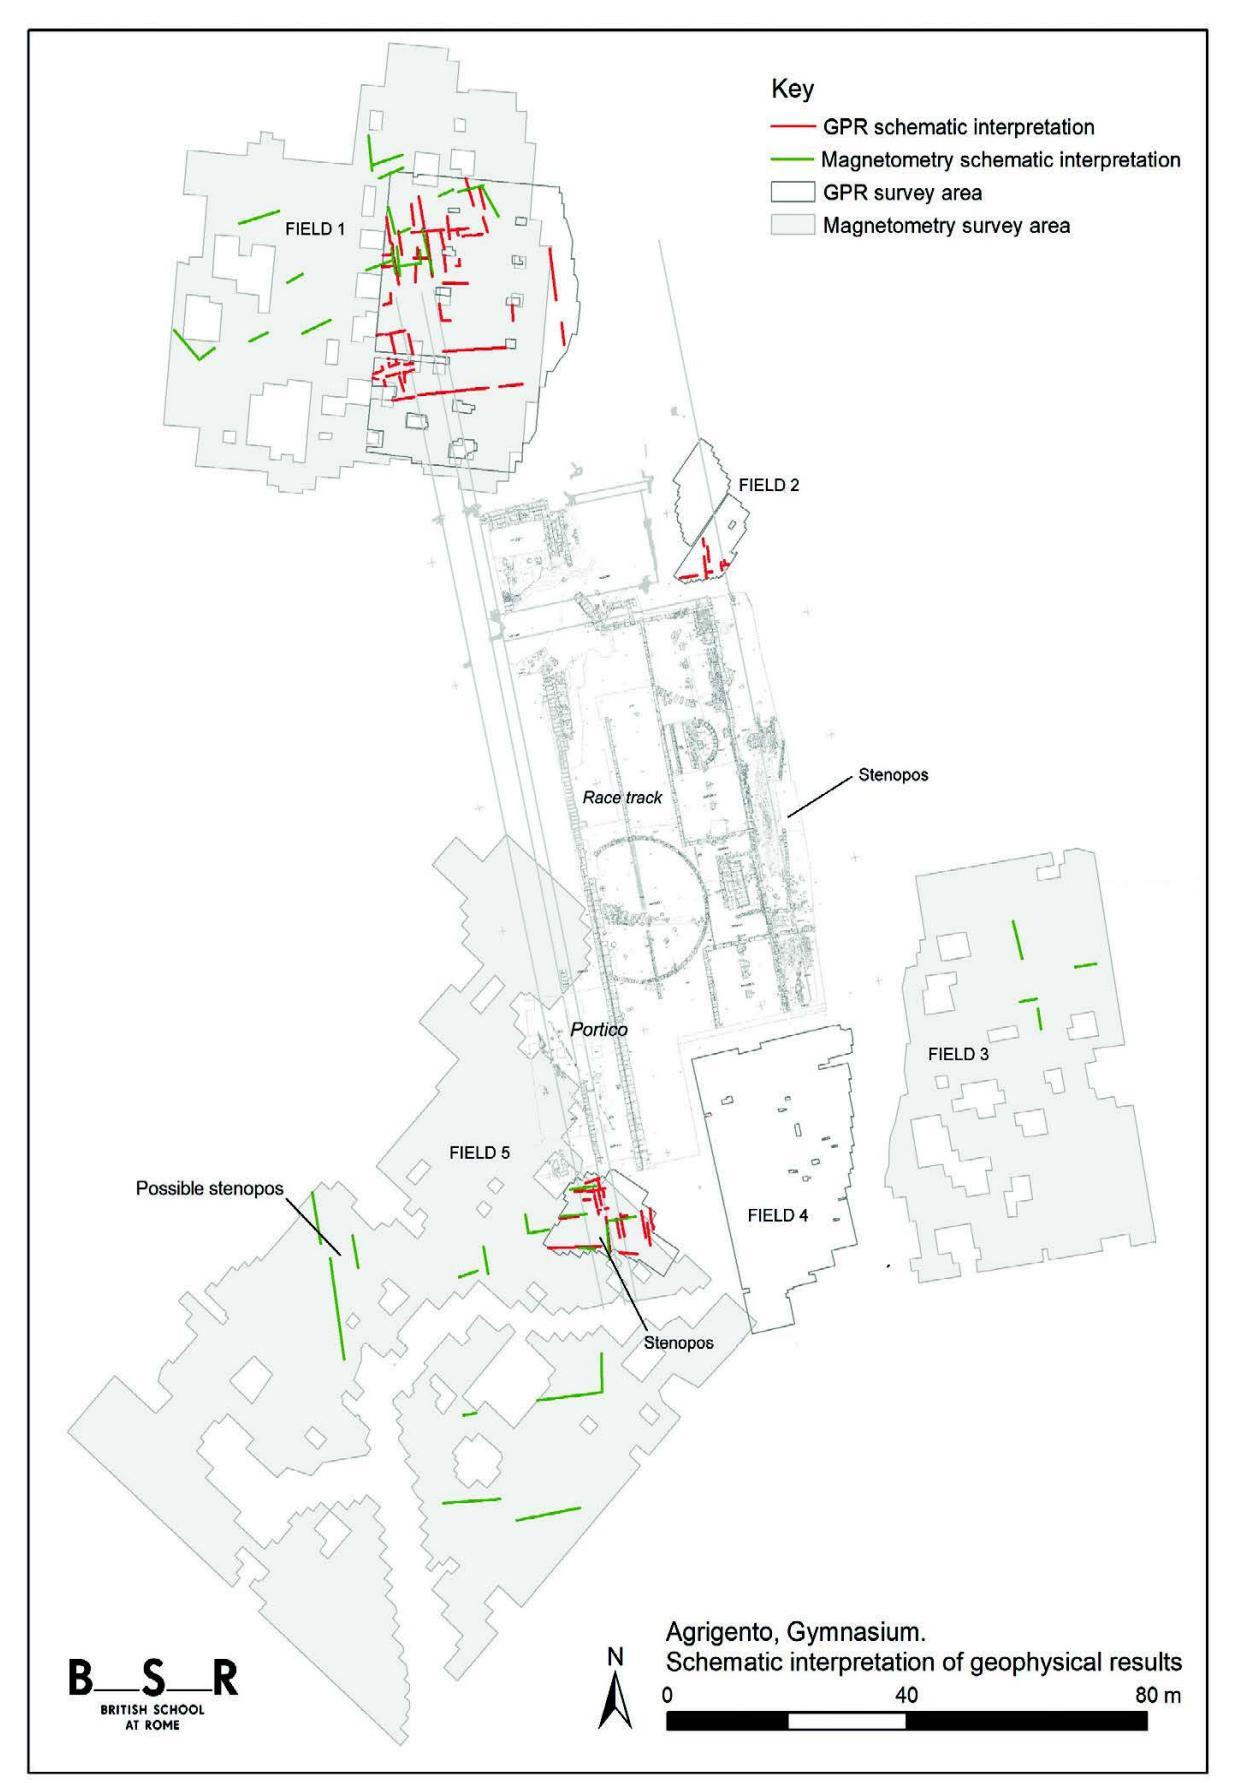
Fig. 1: Schematic overview of the geophysical survey results (Trümper et al. 2022, 158 fig. 33).

Based on the results of the architectural and geophysical surveys carried out in 2020 and published in 2022¹, a first excavation campaign was carried out and the architectural survey was continued. The geophysical survey suggested that a palestra building which is typical of gymnasia in the eastern Mediterranean might have been located in an olive grove to the north of the pool (fig. 1). Four trenches were excavated in this olive grove in a terrain that rises more than 4 m from south to north (fig. 2).

Trench 3 was excavated in the area of the hypothetical continuation of the western stenopos and where the geophysical survey had identified the highest concentration of anomalies (figs. 1, 5). The continuation of the stenopos was found, in perfect alignment with the remains to the

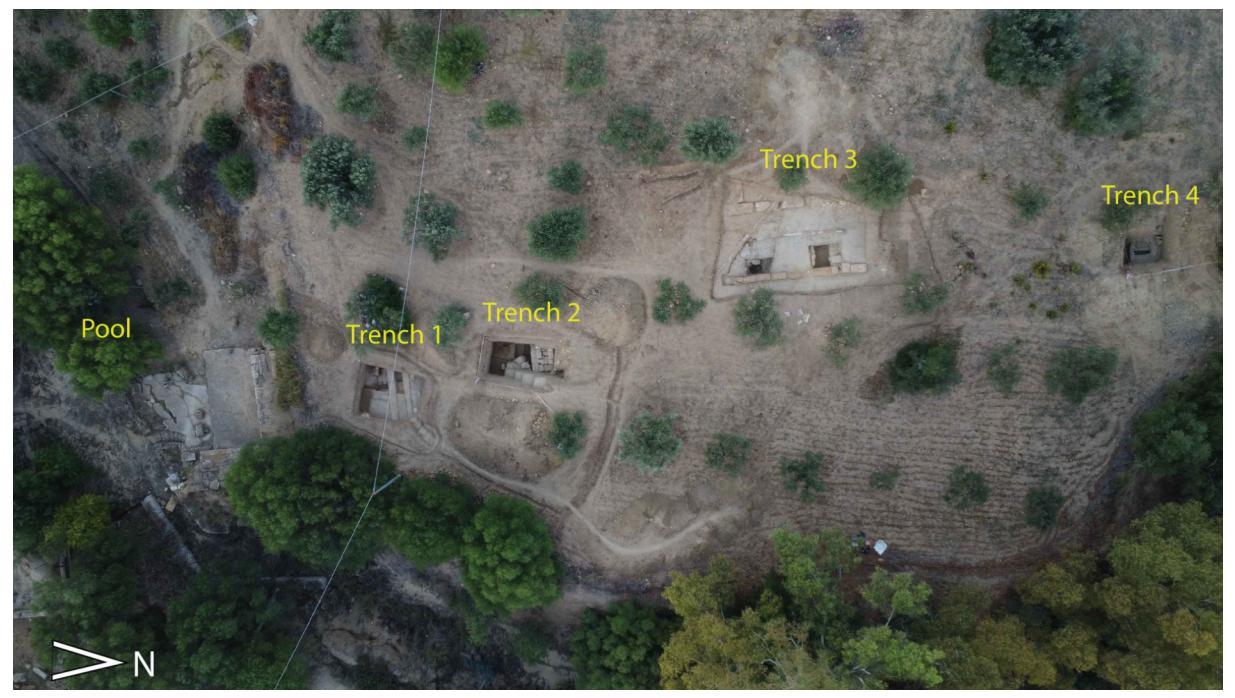
Fig. 2: Location of trenches in 2022 (Monika Trümper, © Freie Universität Berlin).

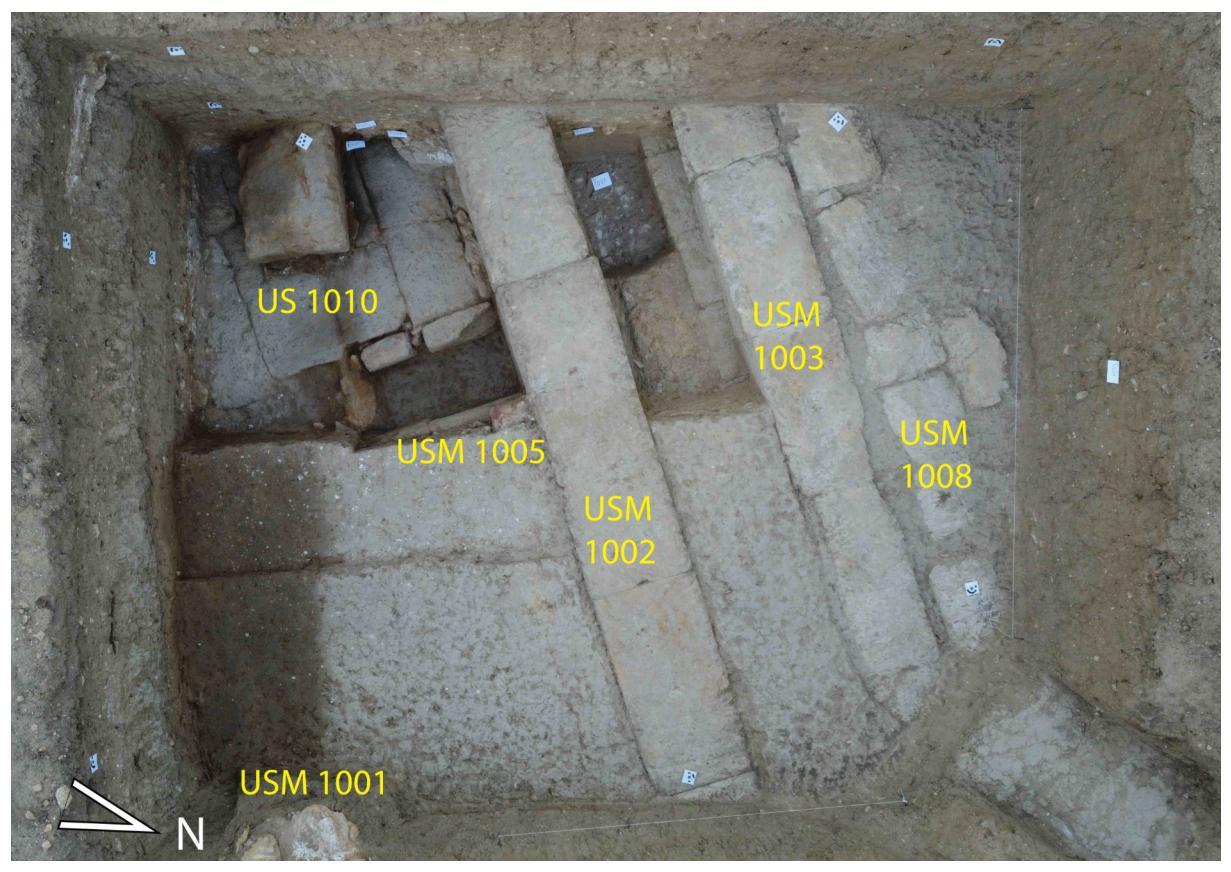
Fig. 3: Trench 1, drone photo at the end of excavation (Thomas Lappi, © Freie Universität Berlin).

Trench 1 was located in the immediate vicinity of the pool to investigate the connection of the pool complex to the possible palestra building (fig. 3). Two ashlar walls, running parallel in a distance of 0.70 m from each other and roughly from east to west, were found as well as a wall running north-south perpendicular to the ashlar walls. The walls are consistent in orientation, building technique, and material with the previously exposed walls of the gymnasium. A pavement of large stone slabs was revealed in the southwest corner of the trench.

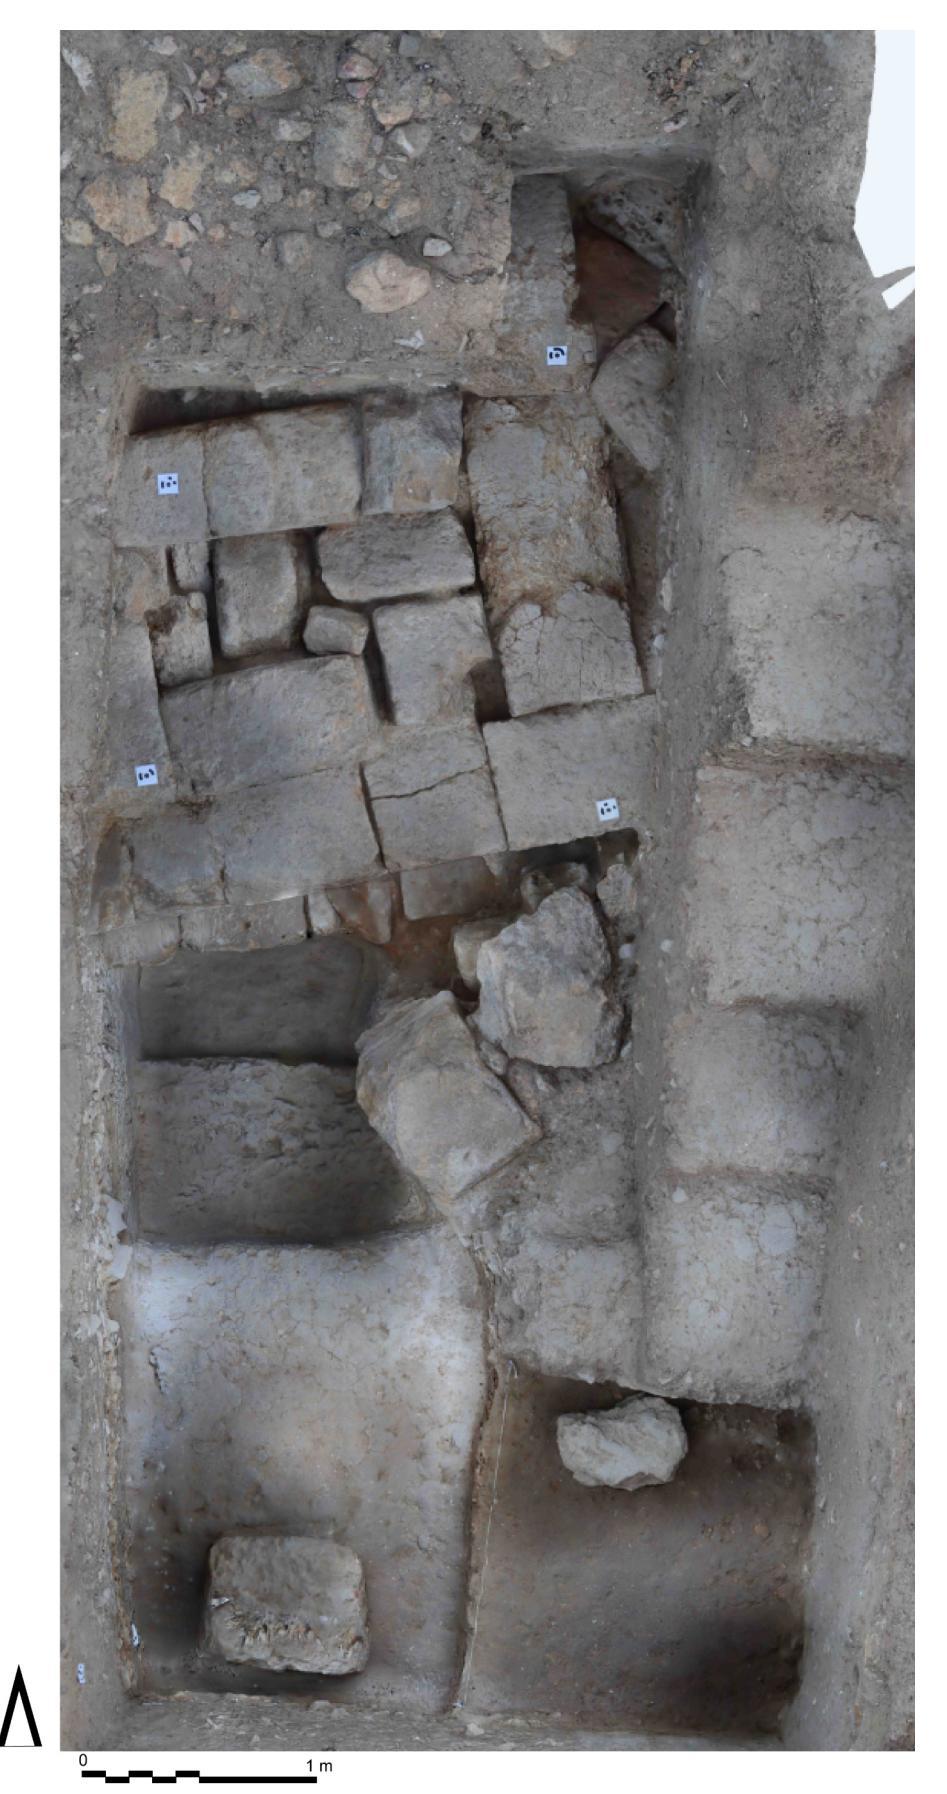
Fig. 4: Trench 2, orthophoto at the end of excavation (Florian Birkner, Monika Trümper, © Freie Universität Berlin).

Trench 2 was excavated where the geophysical survey had identified an east-west oriented anomaly (fig. 4). A massive ashlar wall, running east-west, and a perpendicular north-south running wall were revealed. They correspond in orientation, type of construction, and material with the walls from Trench 1. The walls were built without a foundation trench directly on a clay bed. Therefore, their construction date could not be securely determined. The walls subdivided at least three spaces. A sima block found turned-over to the south of the walls suggests that there was a colonnade nearby, probably the peristyle courtyard of the palestra.

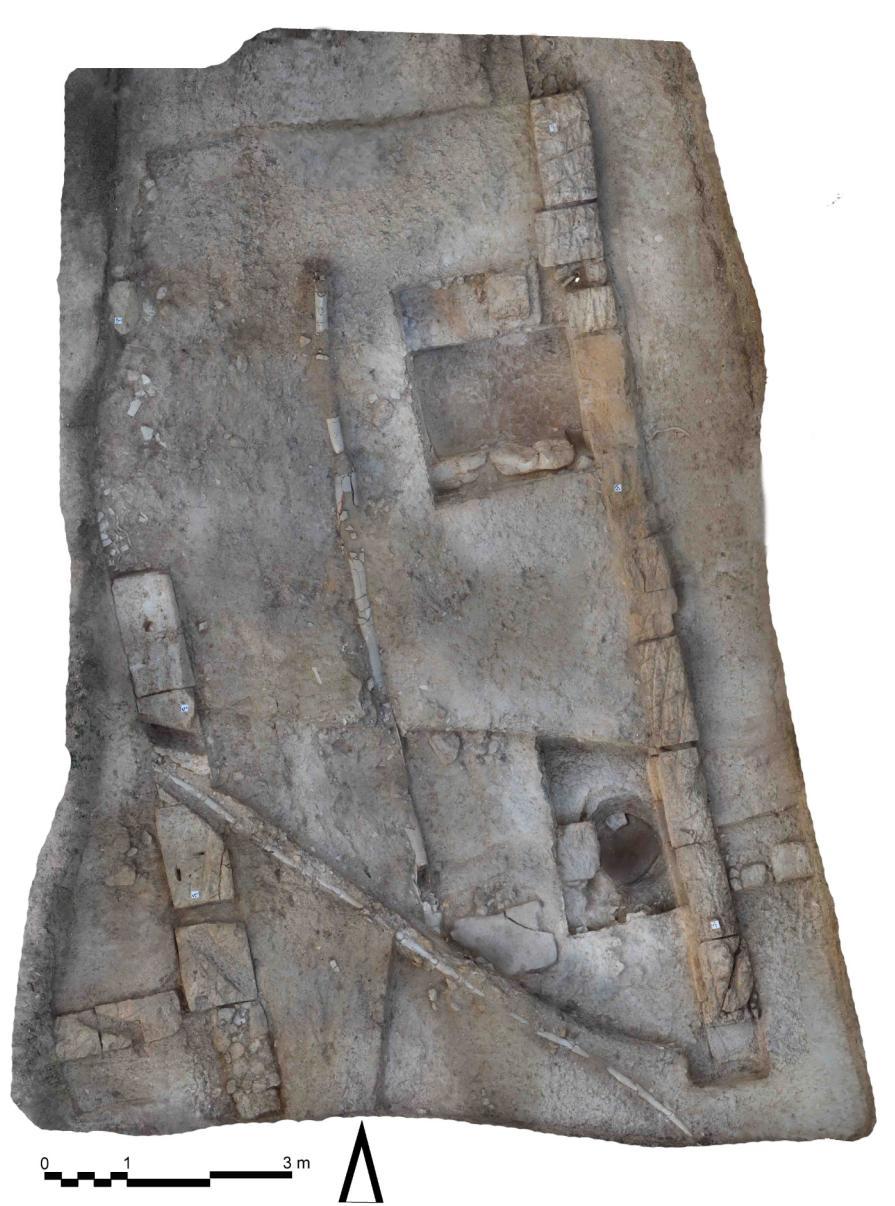
Fig. 5: Trench 3, orthophoto at the end of excavation (Blanca Kupke, Francesca Spadaro, Monika Trümper, © Freie Universität Berlin).

west of the race-track section and the pool. The newly excavated part of the stenopos is 5.30 m wide and flanked by two parallel running ashlar walls. An ancient channel made of terracotta pipes and reused Punic amphorae was revealed running north-south in the center of the stenopos. A second channel of thin terracotta pipes running from northwest to southeast was dated to the 18th/19th century.

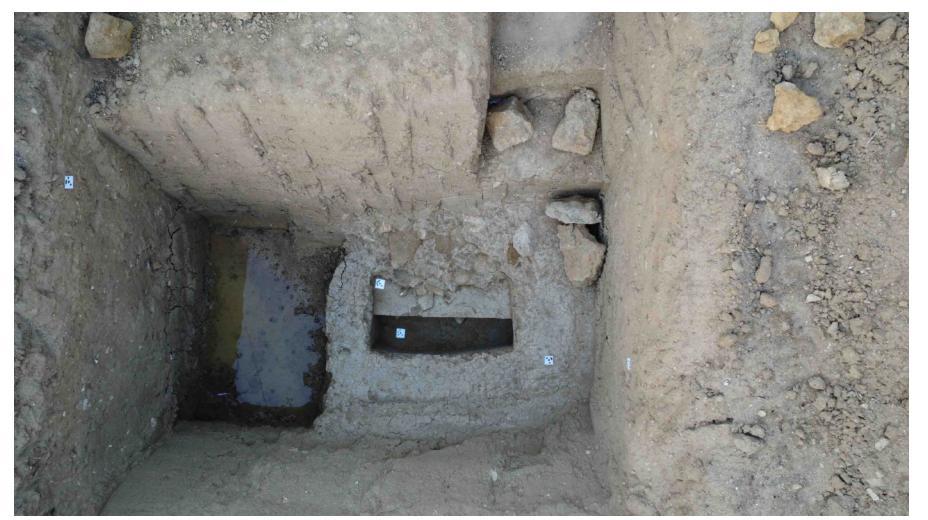
Fig. 6: Trench 4, drone photo at the end of excavation (north it at the right side) (Thomas Lappi, © Freie Universität Berlin).

Trench 4 was excavated at the hypothetical crossing of the western stenopos with a plateia (fig. 6). The excavation revealed no built structures. Instead, several alluvial layers sloping from west to east were met. A comparison with similar findings in Agrigento suggests that, in ancient times, there was a course of water in the immediate vicinity to the north, which regularly flooded the area. This trench shows that the orthogonal grid plan of Agrigento was adapted to the topographical conditions.
