**American Excavations at Morgantina – South Baths Project 2013
Preliminary Report
Sandra K. Lucore and Monika Trümper, Co-Directors South Baths Project**

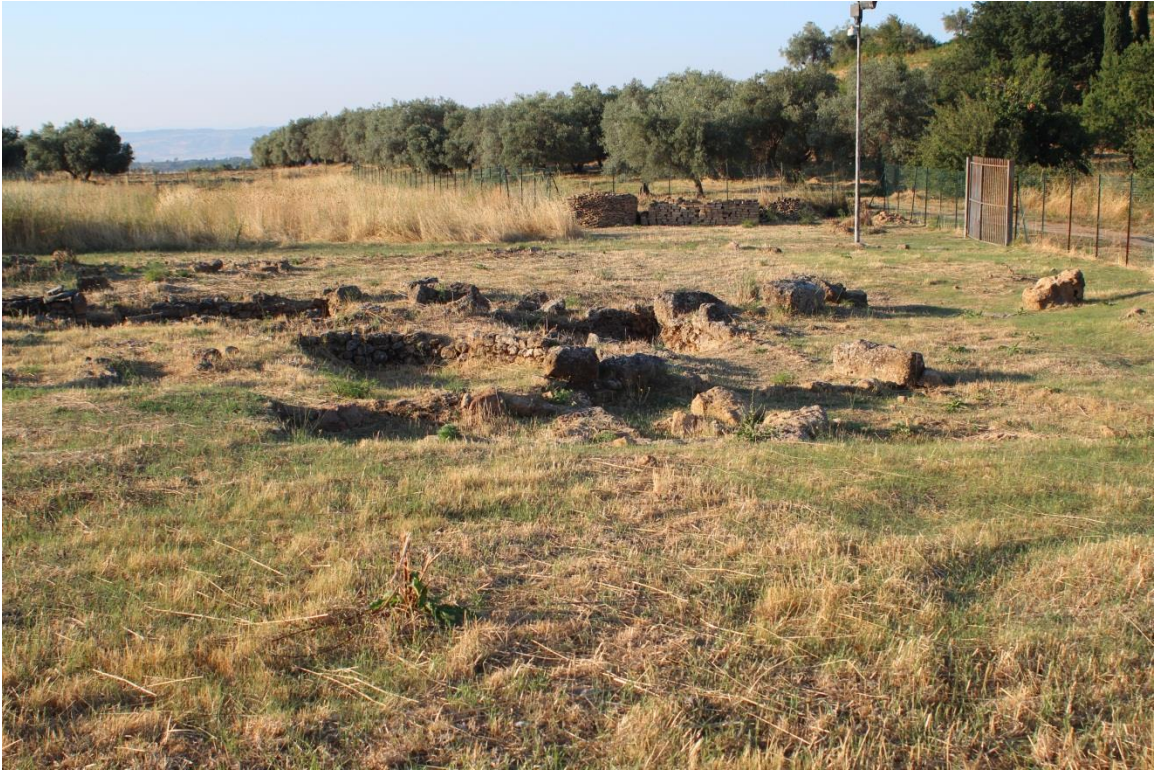
South Baths, before excavation from N

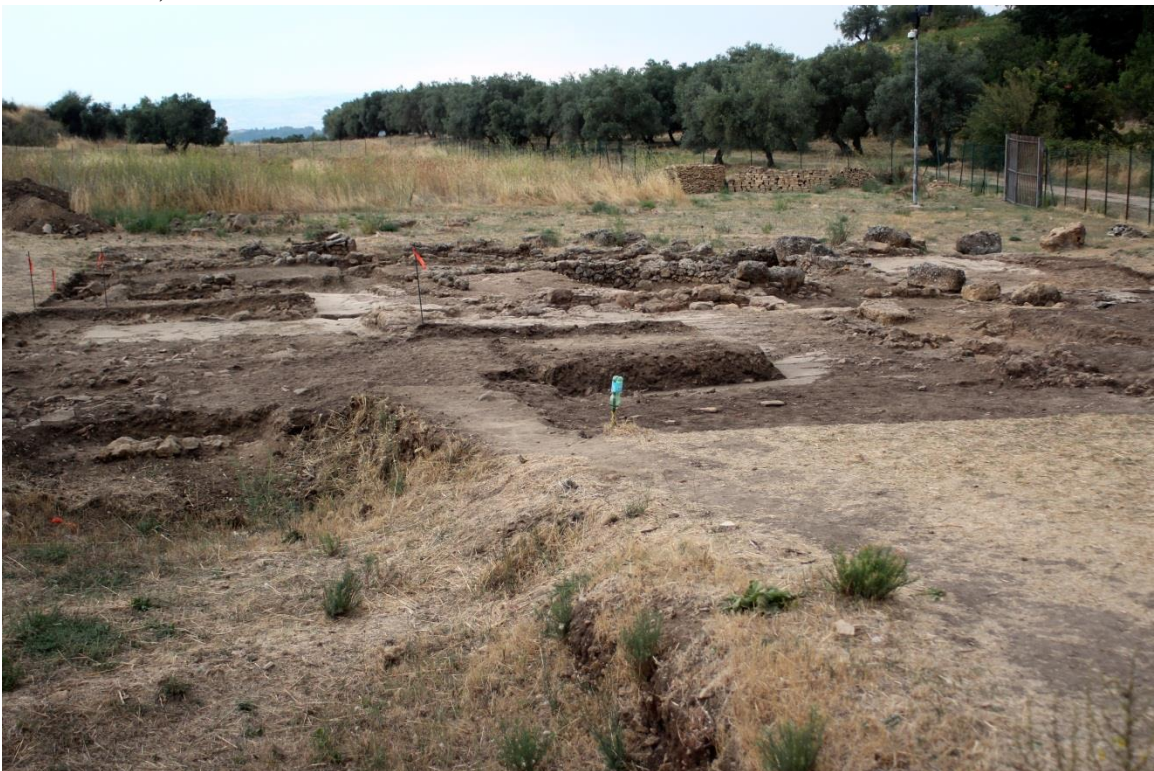
South Baths, after excavation, from N
